# Blackmore River and Estuary

## Summary

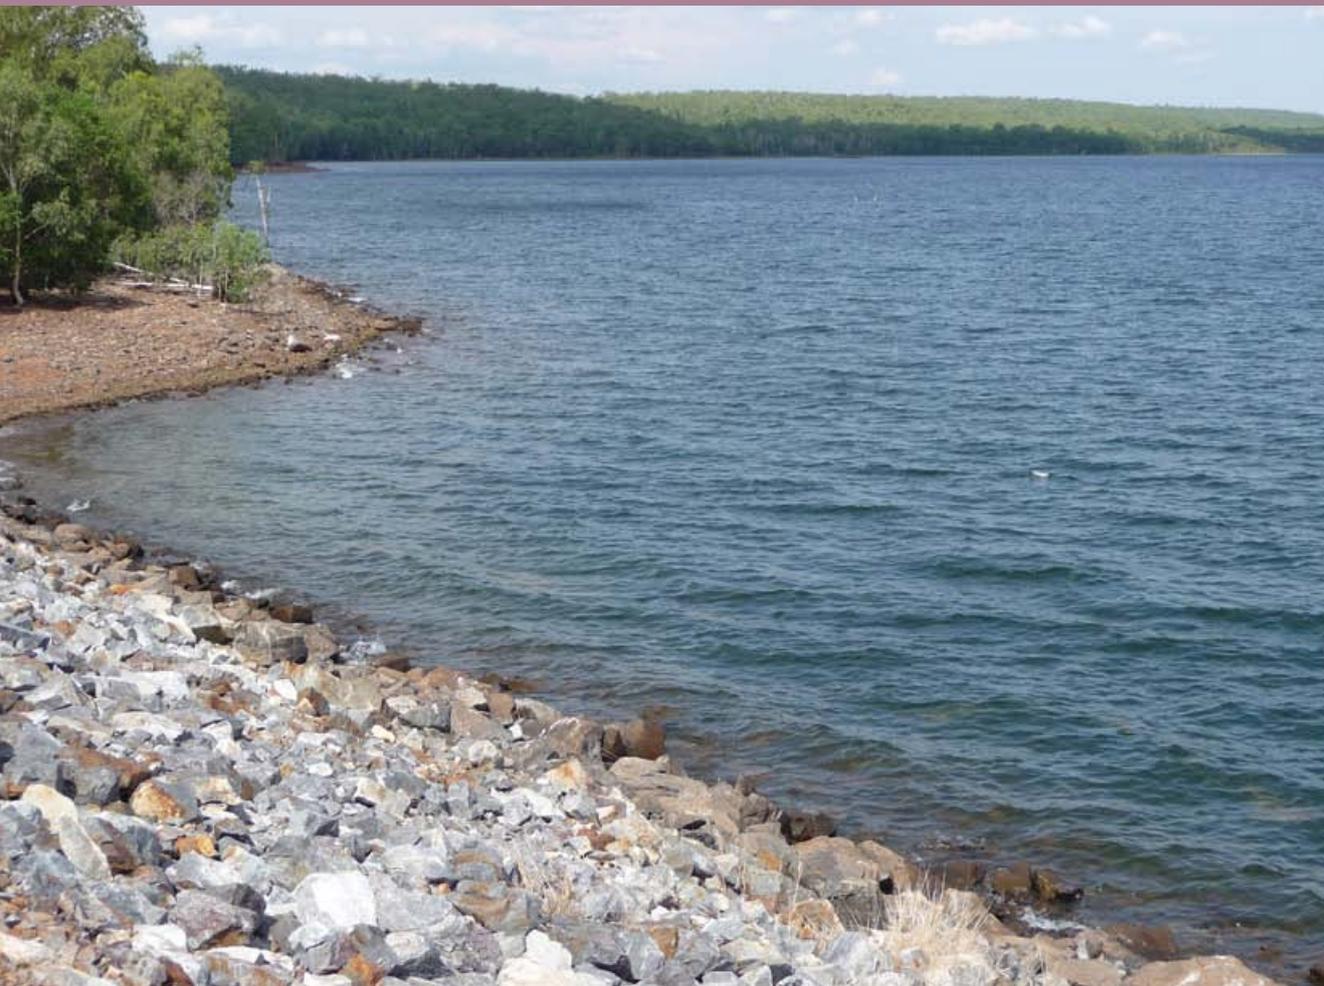
Darwin River Dam was constructed in 1972 and is designed to supply 200,000 people. Photo: John Drewry

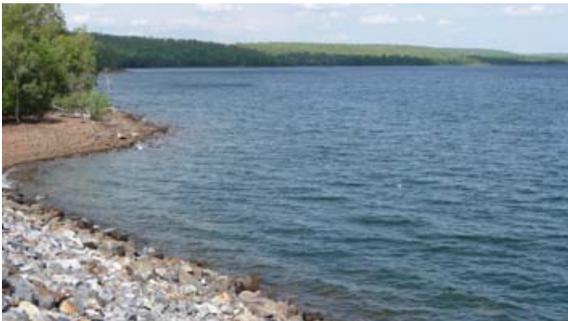
Darwin River Dam is the main drinking water supply for Darwin and surrounding area. Darwin people use up to three times more water per capita than in other Australian capital cities.

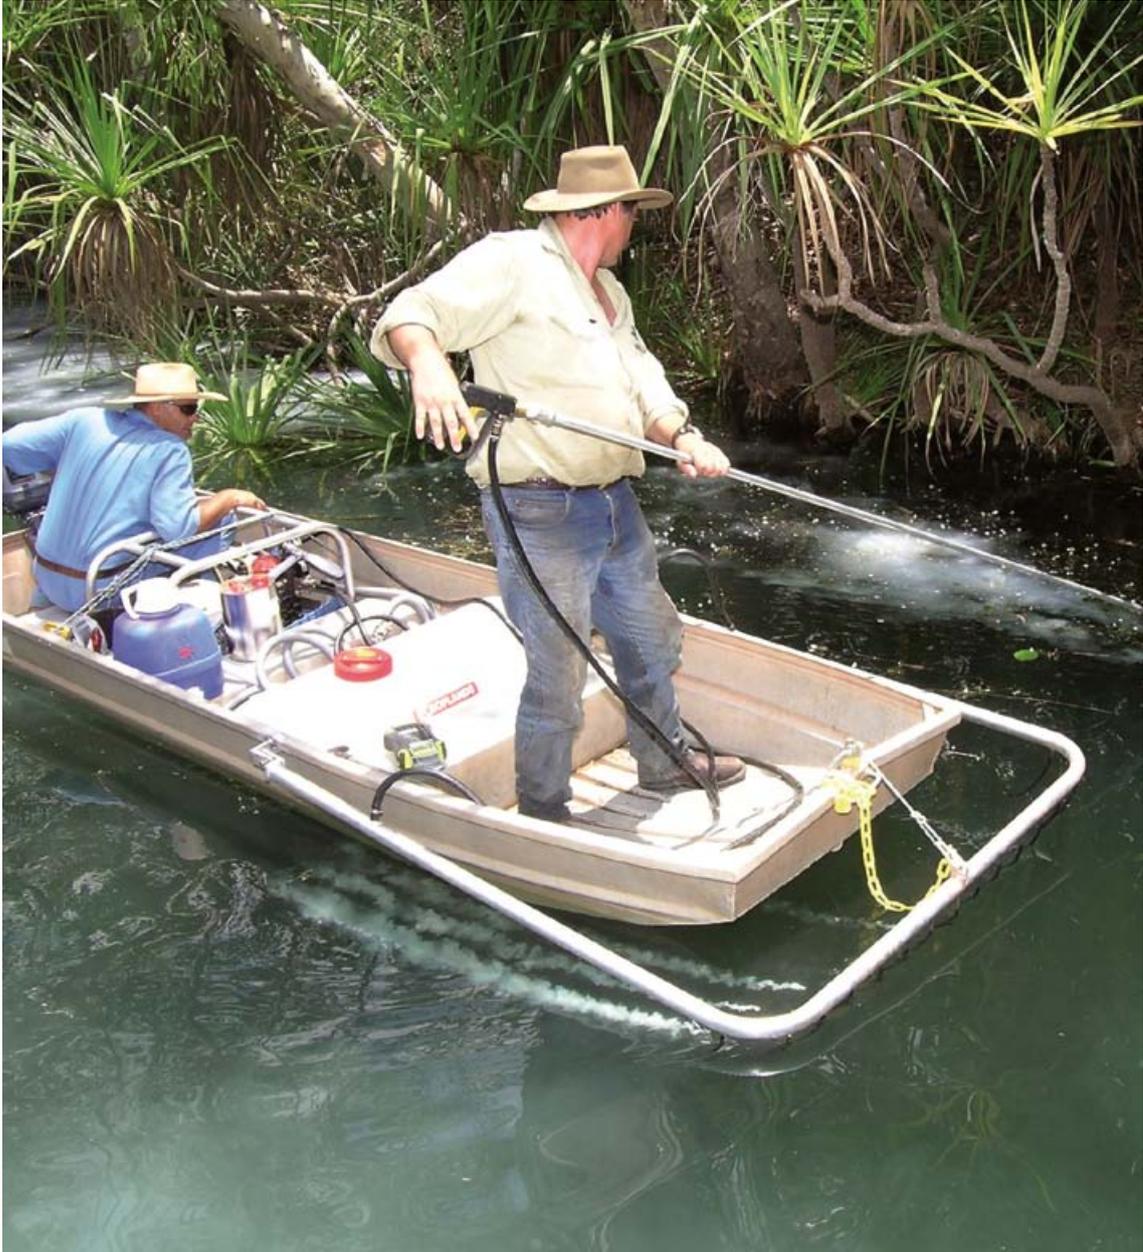
In the eradication program, herbicide is mixed with diatomaceous earth and applied directly onto submerged plants to minimise herbicide use and risk of off-target impacts.

The eradication program has reduced and contained the cabomba population to less than 1% of the level found in 2004. The program has prevented the re-establishment of infestations, production of flowers and seeds at all sites and also further spread and establishment. A monitoring program monitors water quality and macroinvertebrates. No off-target impacts within the project area or at downstream monitoring sites have been detected.
