Northern
Territory
Government

DEPARTMENT OF LAND RESOURCE MANAGEMENT

End of dry stream flow measurements, Katherine and Daly River, October 2013

Report .11/2013D
Daniel Wagenaar
October 2013

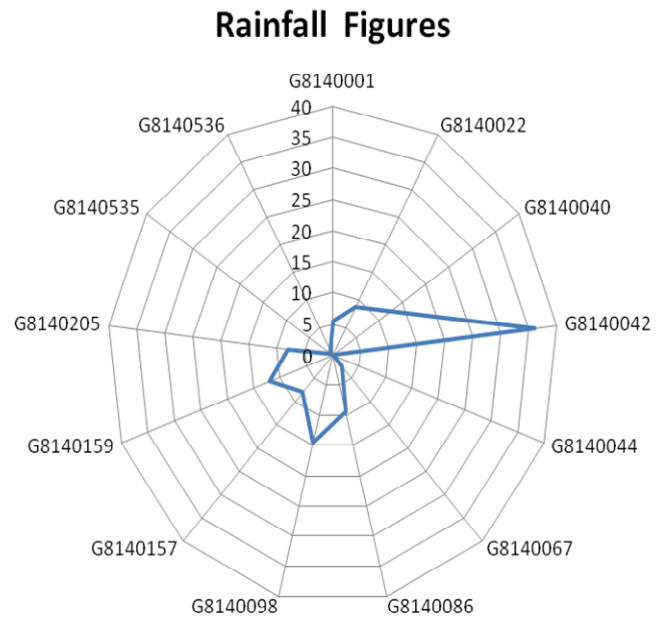
Figure 3 Rainfall Figures

Rainfall data was collated from monitoring sites in the catchment over the same period as the “snap shot” measurements exercise to identify if local runoff affected the field measurements.

The rainfall data transmitted via telemetry from monitoring sites to Hydstra database was used for this purpose.

The base flow conditions during the “Snap Shot” measurement exercise could be affected as result of surface water runoff generated by rainfall in the immediate catchment. The total rainfall figures from 1 October to 19 October 2013 at each of the monitoring sites are supplied in Figure 3. The rainfall events at G8140042 and G8140098 occurred 24 hours before the flow measurements were performed at the respective monitoring sites.

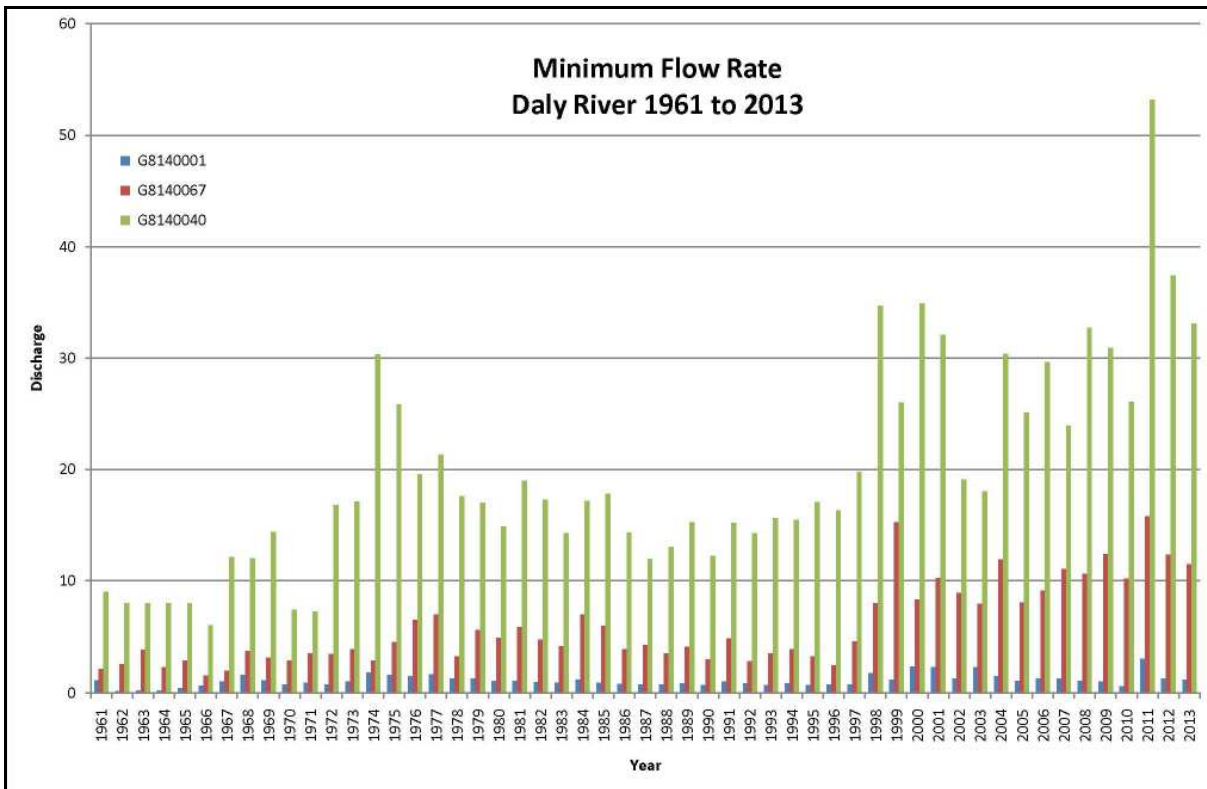
Figure 5 Minimum Annual Flows

The stream flows measured in October 2013 at Katherine Railway Bridge (G8140001), Dorisvale (G8140067) and Mount Nancar (G8140040) are graphically shown in Figure 5 against the minimum annual flows from 1961 to 2012 at each of the monitoring sites. The October 2013 stream flows are well above the average minimum flow at each of the respective sites although the flows do indicate that there is a reduction in base flows over the past three years.

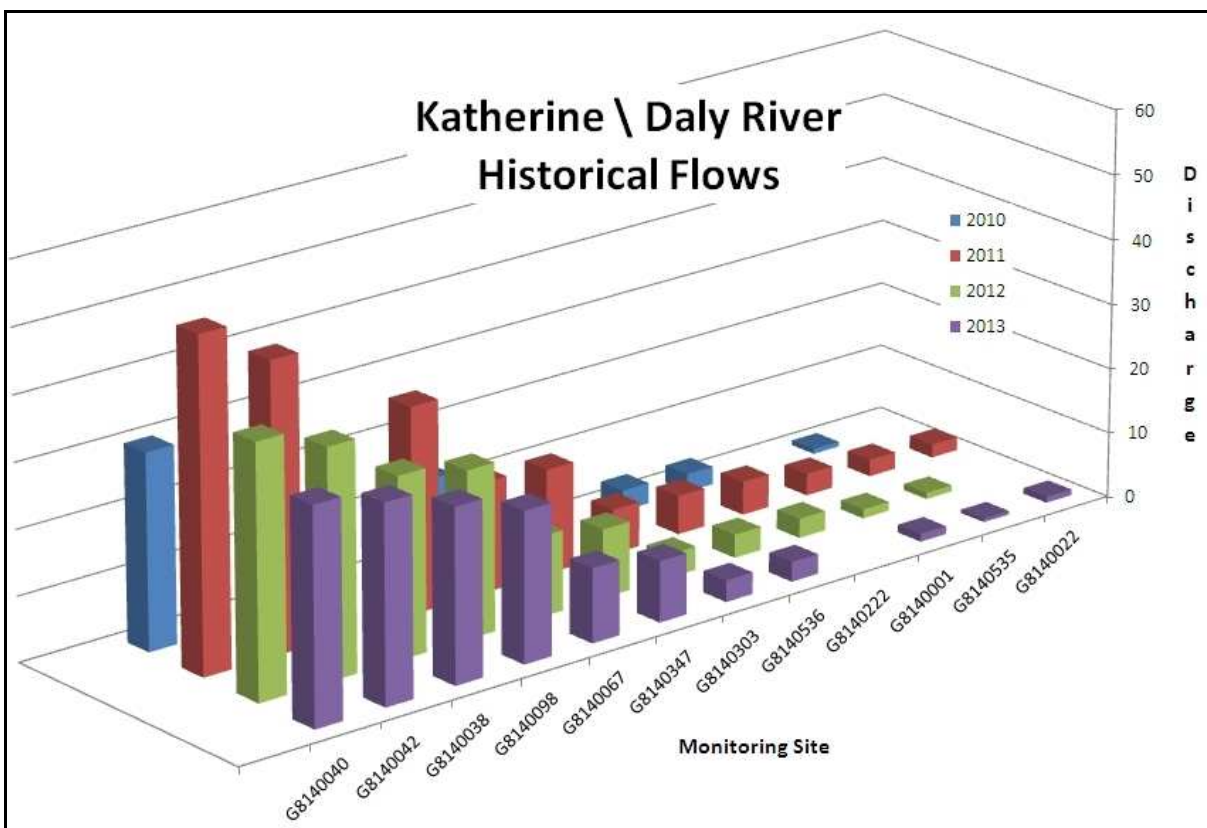
Figure 6 Historical Flows

Substantial flow measurements were performed in the past at the various monitoring sites and only during the last four years measurements were synchronised within a specific time frame to give a more realistic overview of the catchment conditions. The stream flow measurements performed during the past four years from 2010 until 2013 during the months of September and October in the main river reach are graphically displayed in Figure 6.

The total rainfall during 1 May to 30 April of each water allocation plan year is graphically shown in Figure 7 for Katherine Railway Bridge (G8140001), Dorisvale (G8140067) and Mount Nancar (G8140040) monitoring sites. Although there is not a clear correlation at all monitoring sites between the reduction in flows in Figure 6 and the total rainfall it does verify the variation in base flows over the period.
