# Late dry season stream flows and groundwater levels, upper Roper River, October 2013

Wagenaar, D and Tickell, S.J., 2013, Late dry season stream flows and groundwater levels, upper Roper River, October 2013 Northern Territory Government Department of Land Resource Management, Technical Report No.10/2013D

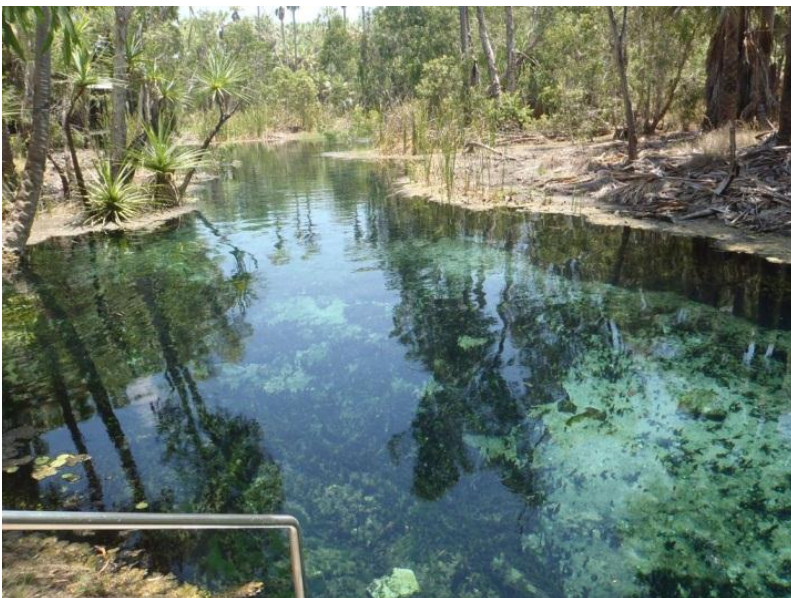
*Plate 1 Bitter Springs looking upstream, (photo S. Tickell)*

Bitter Springs is the largest individual inflow point and consists of a 400m tributary of the Roper Creek flanked by a *Livistona* palm and pandanus swamp with a central channel from 2 to 3 metres deep (Plate 1). Areas of 'boiling' sand were observed on sections of the channel floor but no karstic openings (caves) were seen. The high discharge of the spring suggests that a major cavern(s) supplies the spring. Downstream of the spring the stream gains a further 1.2 cumecs before the creek joins the Waterhouse River to become the Roper River. The major proportion of that increase (0.9 cumecs) occurs upstream of the road to Mataranka Homestead Resort.

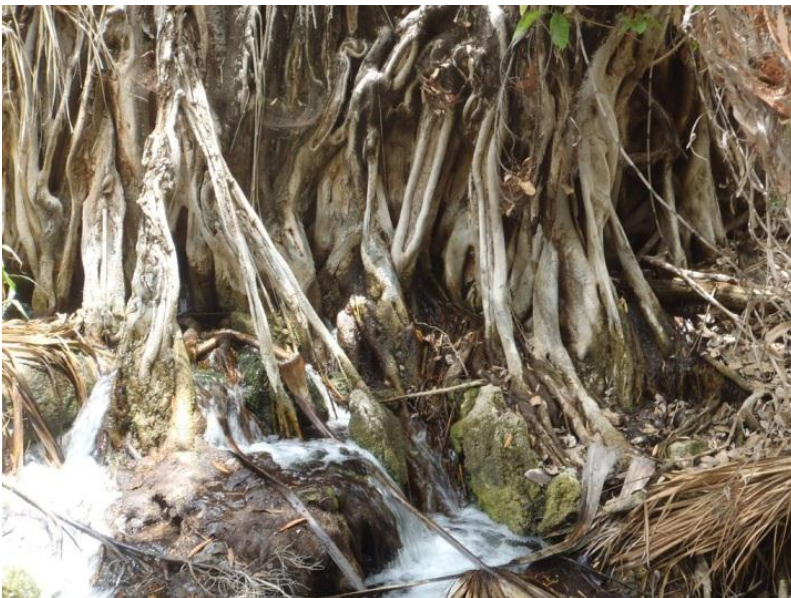
*Plate 2 Fig Tree Spring, (photo S. Tickell)*

Tufa deposits form cliffs up to 9 metres high along the right bank of the Roper River downstream as far as Eley Station homestead. Tufa is a type of limestone formed when calcium carbonate is precipitated from discharging groundwaters, often in the form of natural dams. Small tufa dams are currently active (Mataranka and Roper Falls) but the tufa in the cliffs are fossil deposits formed thousands or tens of thousands of years ago when groundwater discharge was apparently higher. The tufa itself forms a thin fractured and karstic aquifer which is in direct hydraulic connection with the Tindall aquifer below. Groundwater discharging out of the tufa such as at Fig Tree Spring is considered to originate largely from the Tindall aquifer. Fig Tree Spring (Plate 2) has a discharge of about 0.025 cumecs and emerges from small cavities in the base of a tufa cliff. In that area an inlier of Proterozoic sandstone is exposed on the left bank so all discharge to the river likely occurs through the tufa on the right bank.

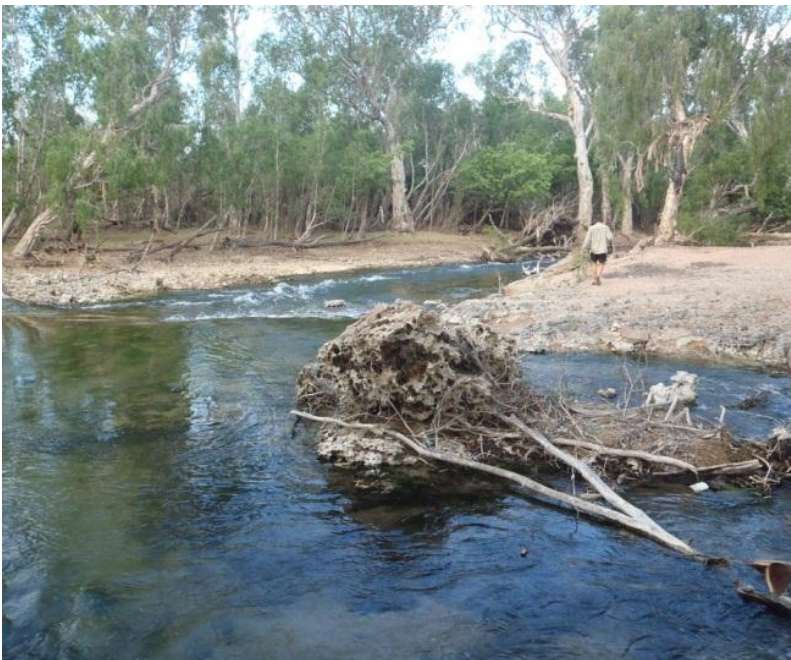
*Plate 3 Elsey Creek at its junction with the Roper River (foreground), ( photo S. Tickell)*

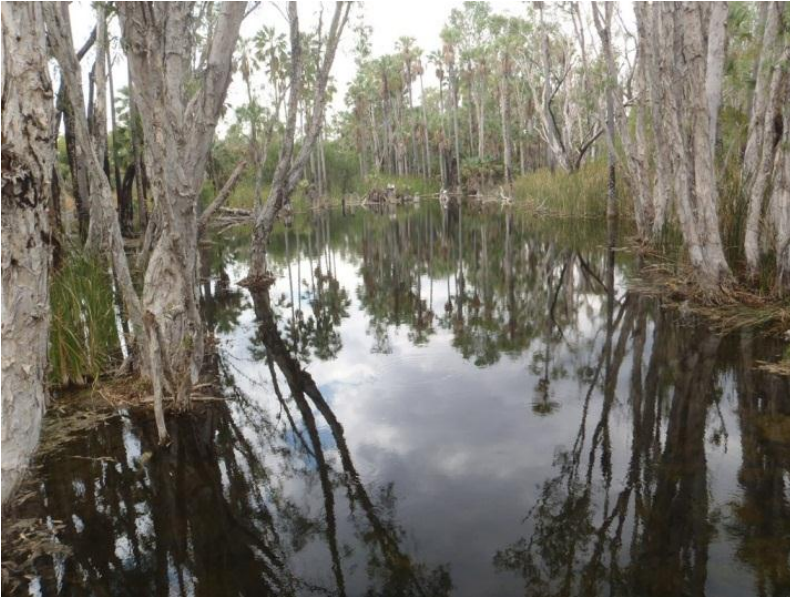
*Plate 4 Elsey Creek at the Roper Highway, looking downstream,(photo S. Tickell)*

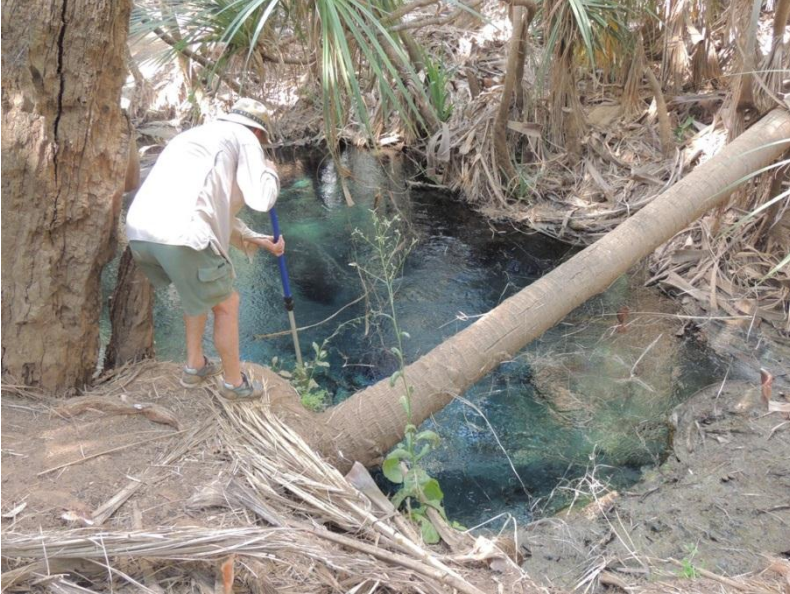
*Plate 5 Water quality sampling at Rainbow Spring, (photo S. Tickell)*

Field measurements were made of basic water quality parameters at all gauging sites as well as a few additional sites. Electrical conductivity (EC), pH, dissolved oxygen, temperature and turbidity were measured (Table 3) (Plate 5). The data has been plotted in the form of a profile along the Roper Creek and Roper River to show any downstream trends (Figure 4).

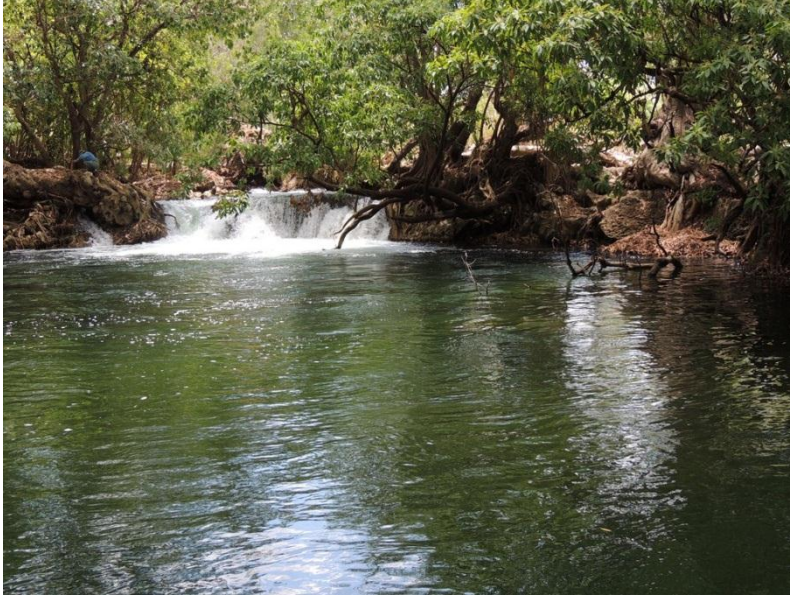
*Plate 6 Roper Falls, a tufa dam on the Roper River, (photo R. Metcalfe)*

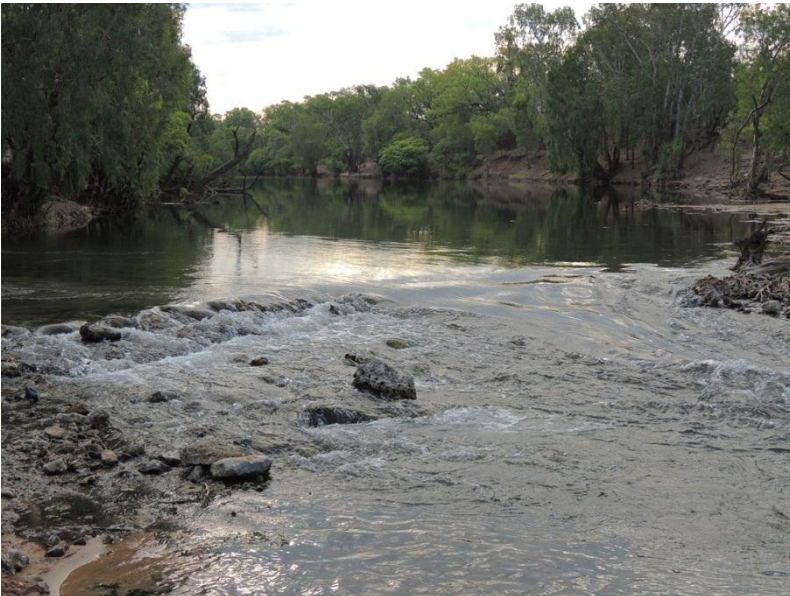
*Plate 7 A rock bar across the Roper River at the Elsey Creek junction, (photo R. Metcalfe)*

It was intended to map the rapids and geology on the Roper River but due to insufficient time only a few kilometres of river upstream of Eley Creek were investigated. As an alternative to a field survey, satellite imagery was used to identify the location of rapids (Figure 4 & Figure 9). A few sites have been visited on previous occasions but the remainder remain to be confirmed on the ground. Two tufa dams known as Mataranka and Roper Falls (Plate 6) are located immediately upstream of Salt Creek and two kilometres upstream of Eley Creek respectively. The rapids in the vicinity of the gauging station G9030176 are made up of Proterozoic sandstone. The ones at the mouth of Eley Creek and at the Eley Homestead ford are Tindall Limestone (Plate 7).

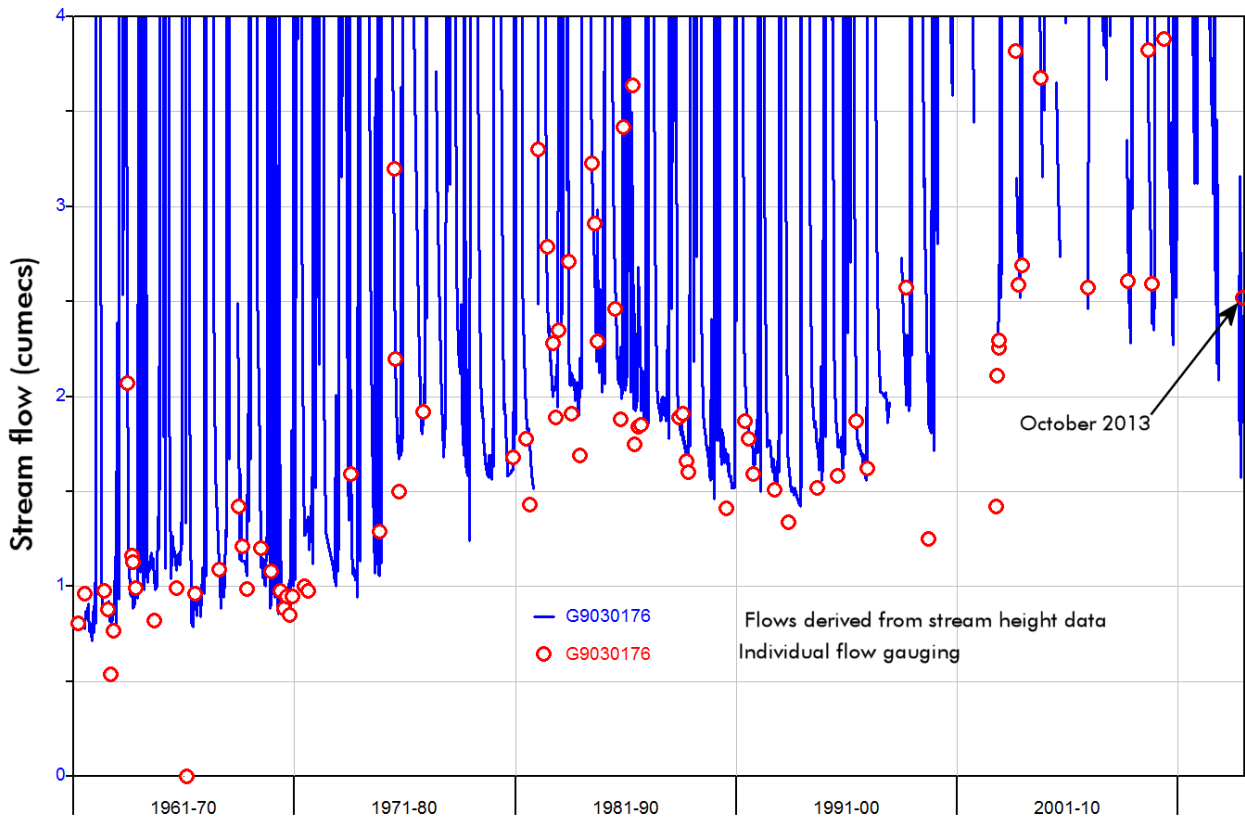
Figure 7 Low flows at Roper River gauging station G9030176

Late dry season flows have been monitored in the Roper River since 1961 at the gauging station G9030176 (Figure 7). The flow of 2.5cumecs measured during the current survey indicates that baseflows since 2003 remain close to the highest on record. This closely reflects the pattern of increasing rainfall since the mid-1970's.

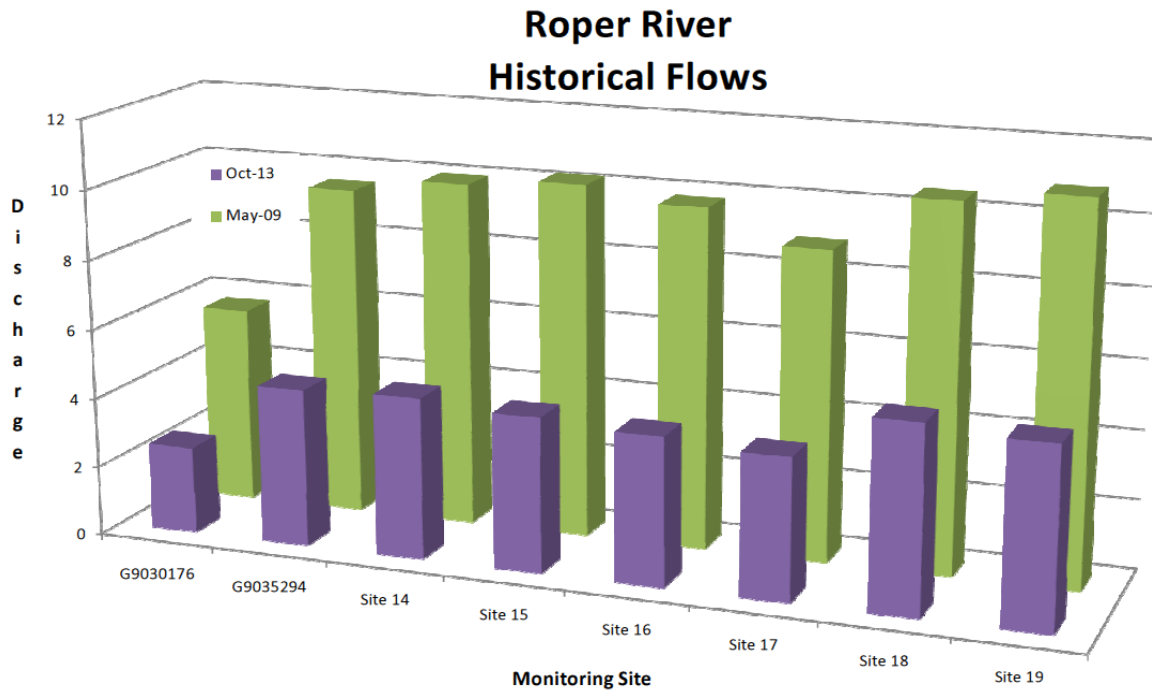
Figure 8 Comparison between May 2009 and October 2013 flow

The measurements performed in May 2009 and October 2013 shows similar trends in both the reduction of flows between sites 14 to 17 and the increasing of flows from site 17 to 19 (Figure 8).

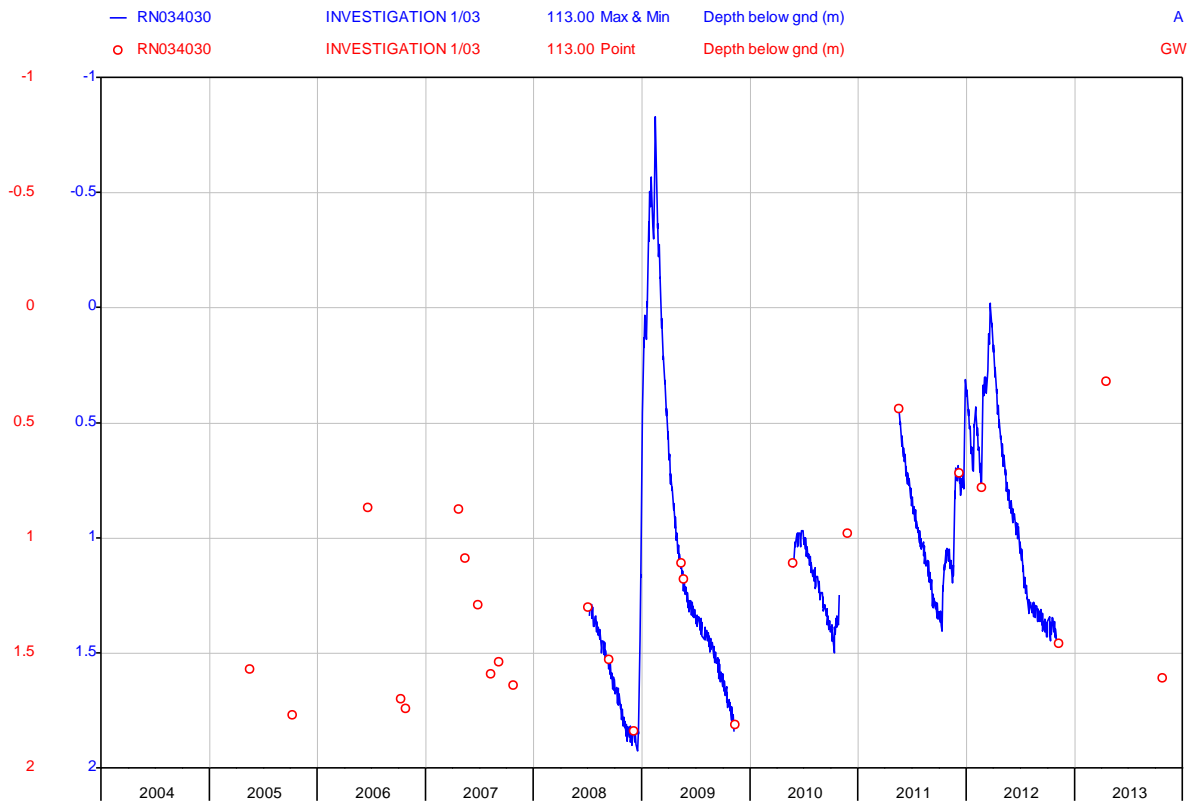
Figure 11 Bore hydrograph of RN034030, the red dots are manual readings and the blue lines are continuous logger data

The longest groundwater level records at Mataranka only date back to 2004. The current readings remain higher than most end of dry season levels from 2005 to 2009 (Figure 11).
