# BR SIMPSON Ecological assessment report

December 2022

BRS1-2 EP93\_97\_107\_EMP\_Appendix A

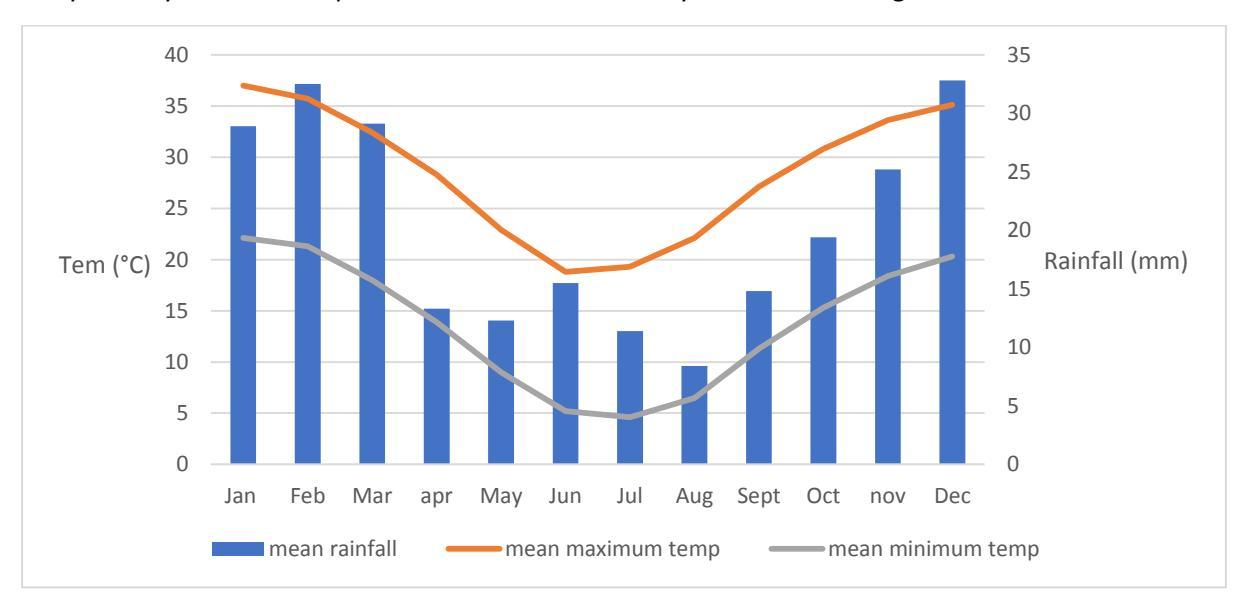
Figure 2-2. Graph of mean rainfall and mean maximum and minimum temperatures for Kulgera.

Data sourced from the Bureau of Meteorology. Data collected between 1980 and 2022 for temperature and 1969 and 2022 for rainfall.

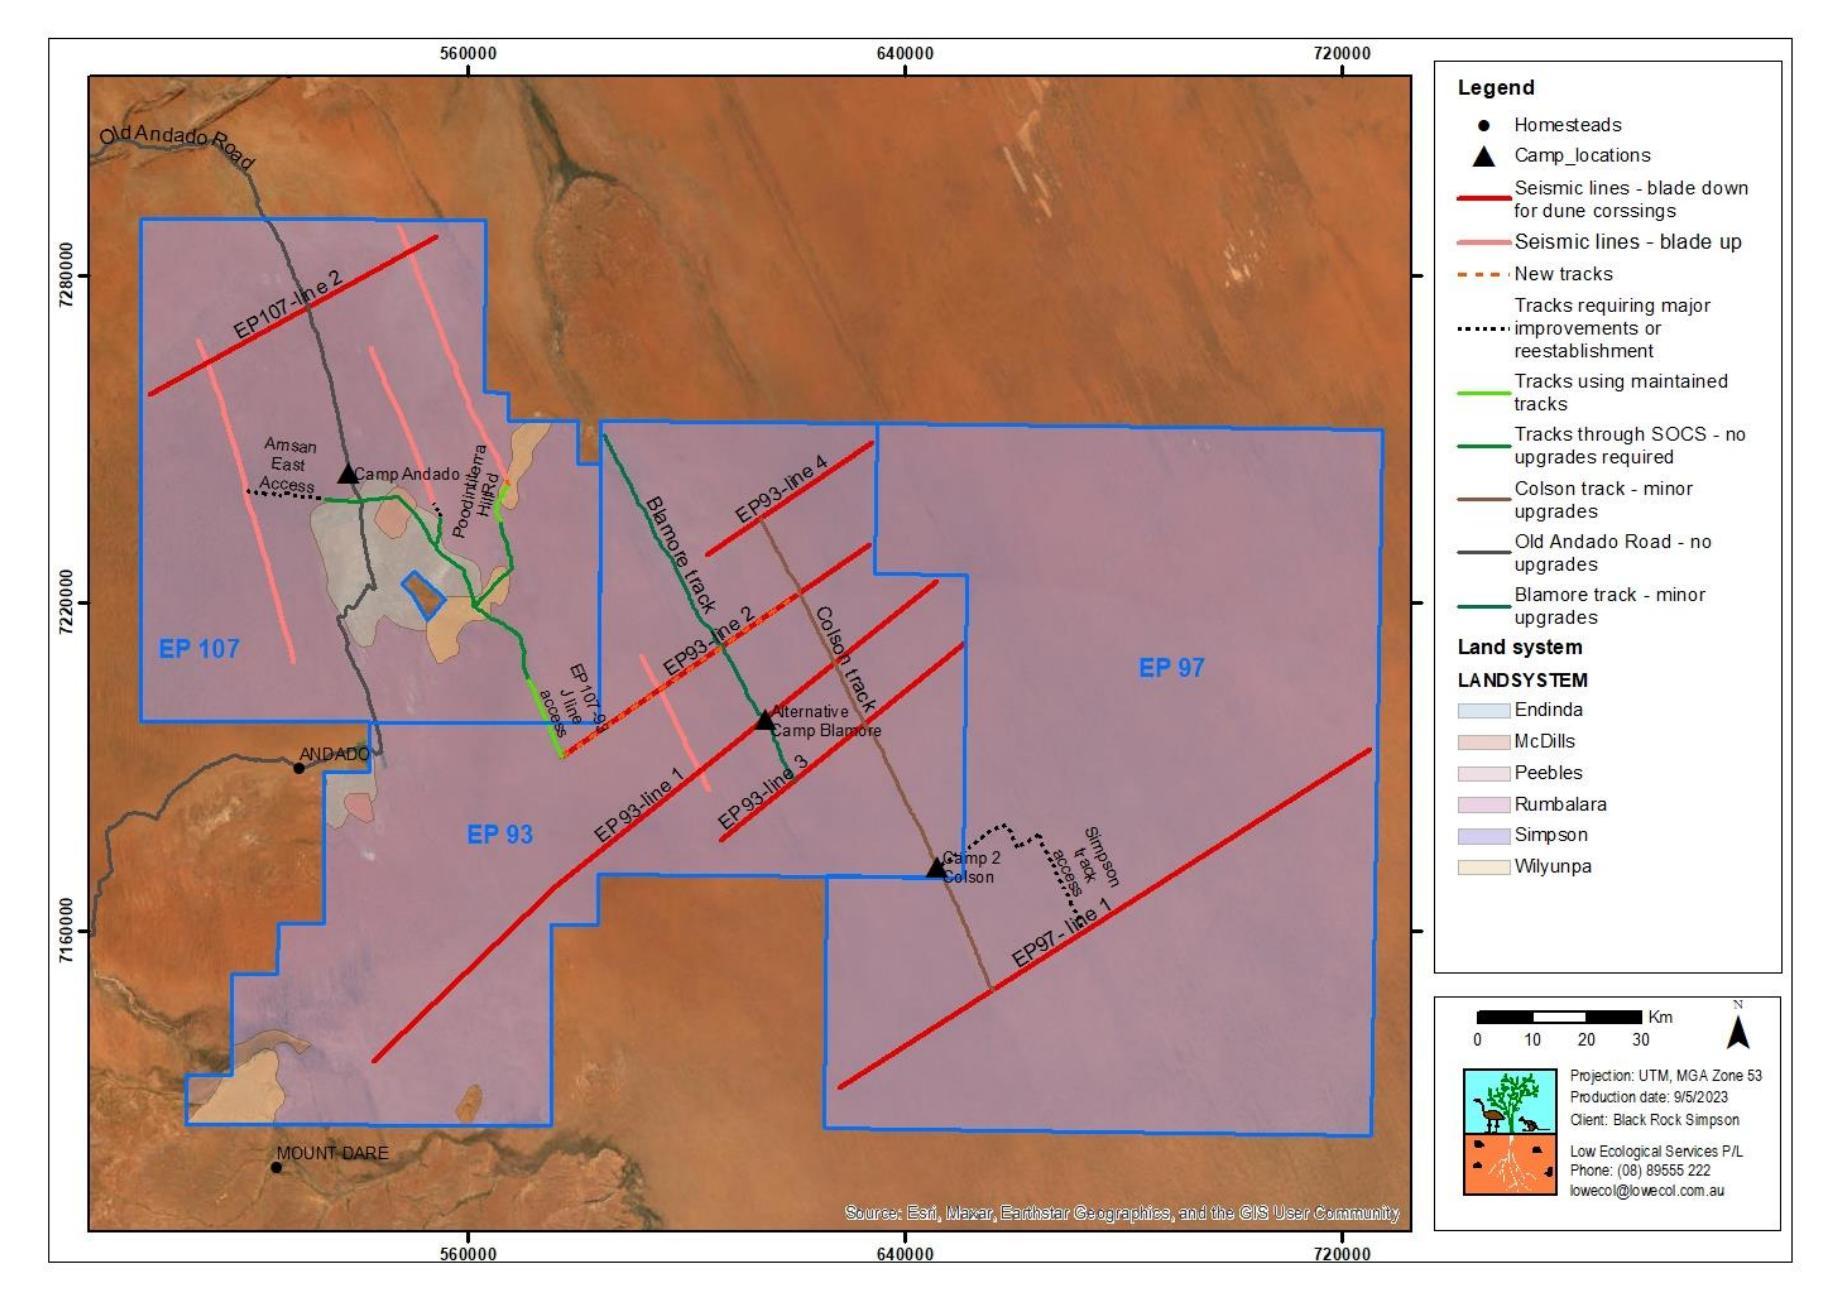
Figure 2-1. Land systems

Table 2-1. Land Systems

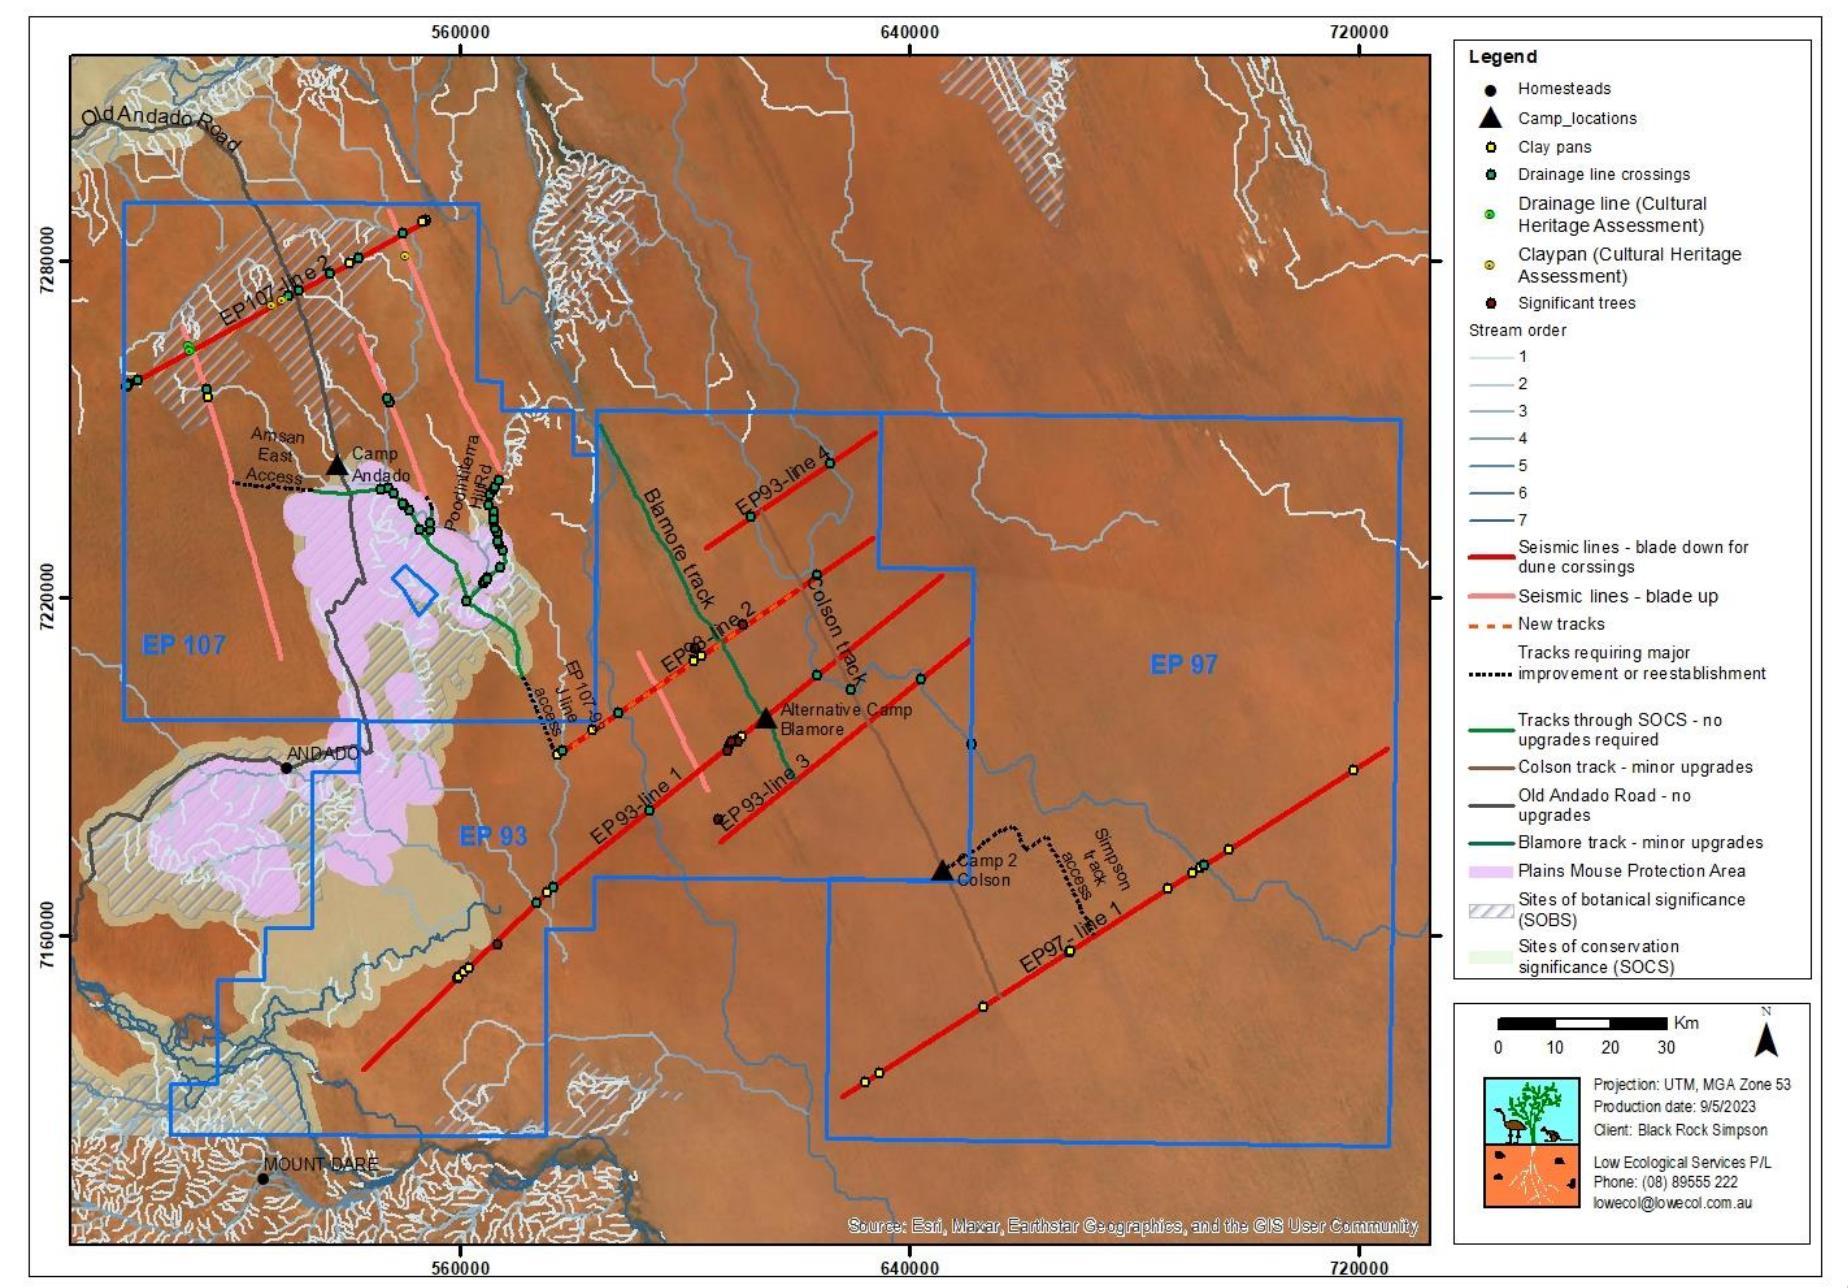
Figure 5-1 Location of drainage line crossings and claypans

minor gully erosion or lined with vegetation) will be implemented as per the ESCP. The locations of drainage line crossings are shown in Figure 5-1 and attached as spatial data.

Drainage lines are prone to weed infestation (predominantly Buffel Grass *Cenchrus ciliaris*) and erosion. During infrequent heavy rainfall events water will generally disperse across the landscape and pool in drainage depressions. The movement of sediment along drainage lines is unlikely to be of major concern if vegetation cover is retained and vehicle disturbance is minimised. Roads and tracks must be graded to ground level and any excess soil, or windrows along the roadside edges must be flattened to prevent water concentration and enable water to move freely across the landscape in an unaltered direction. This will prevent further erosion and sediment transport into drainage lines and ensure that water is able to follow its natural course.

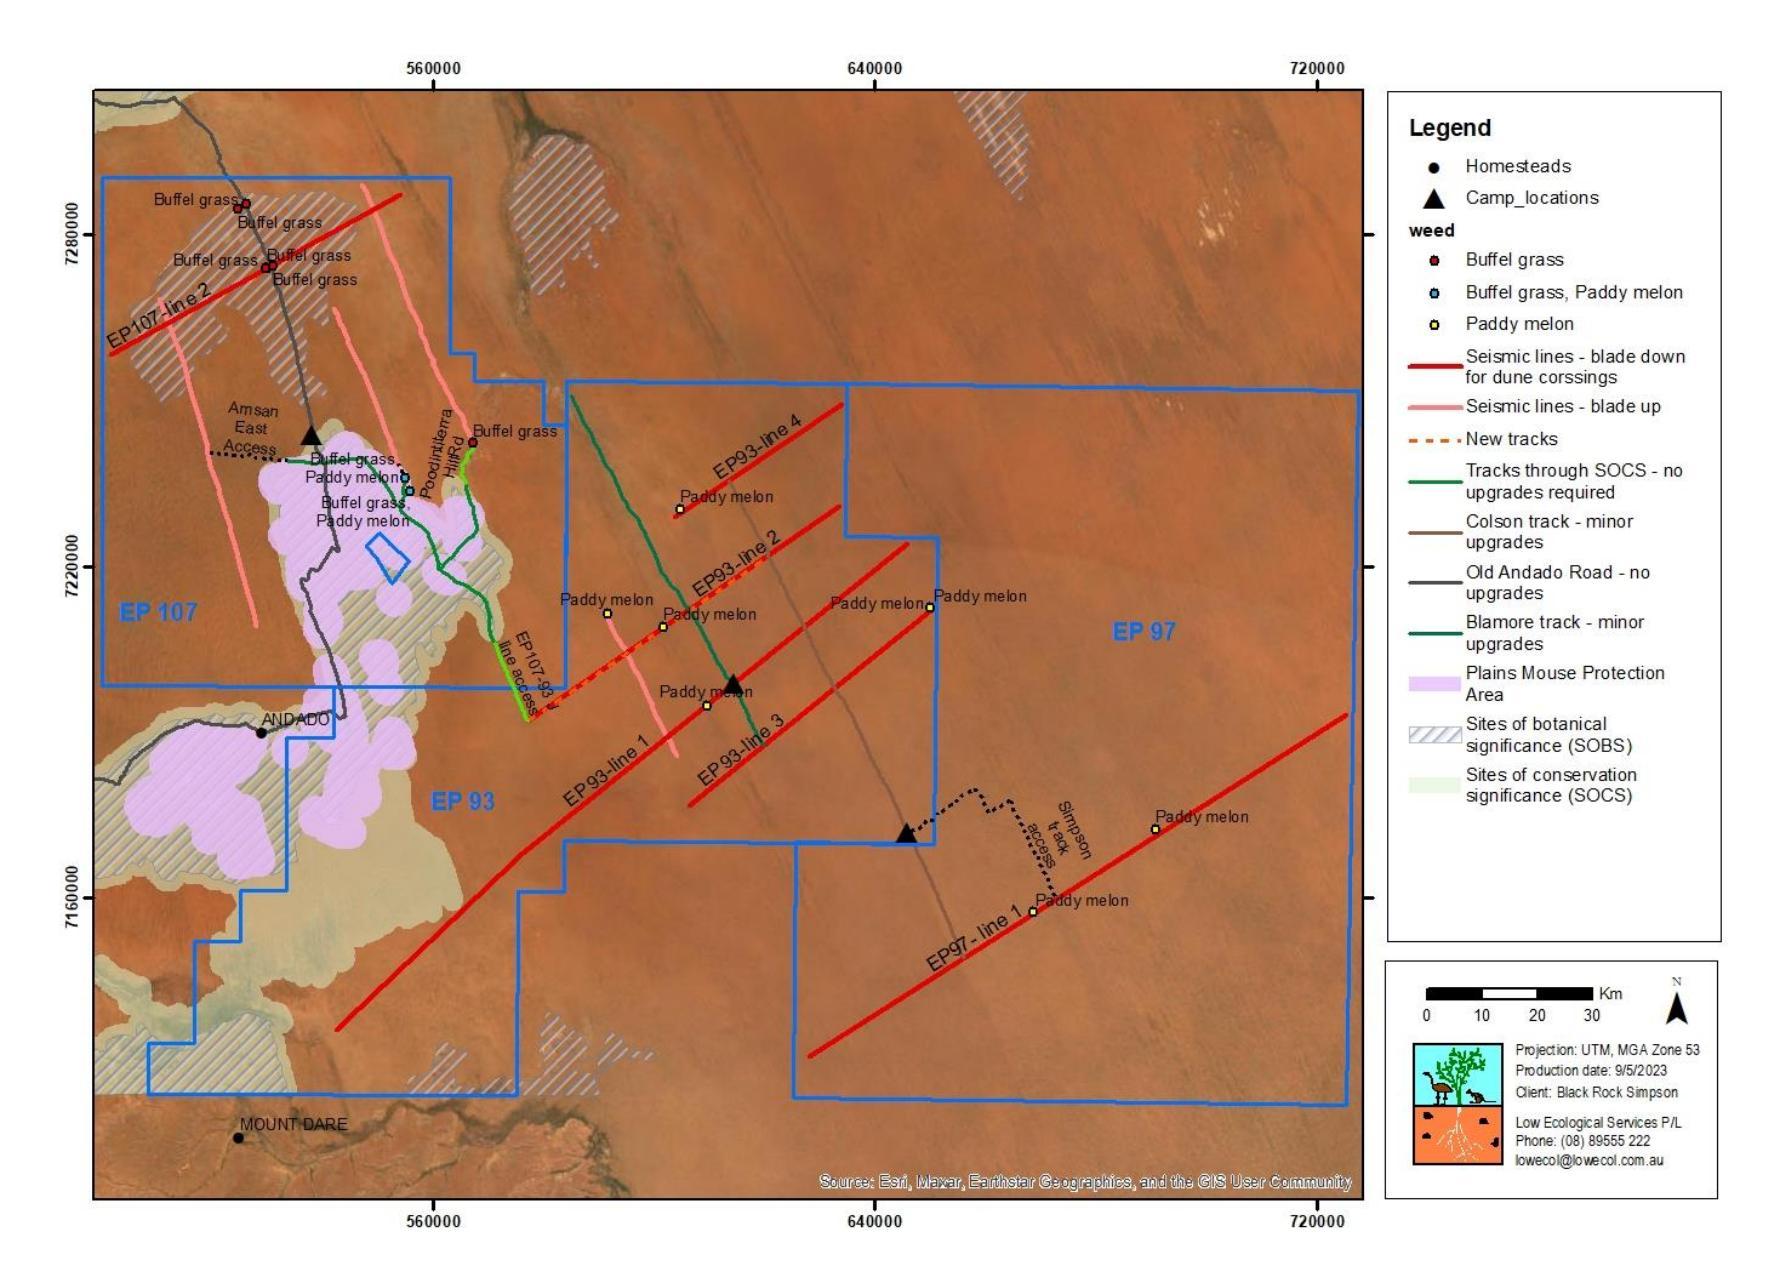
Figure 5-2 Weeds recorded in the project area

During the field survey all weed sightings were recorded (Figure 5-2). There are several different categories for weeds within the Northern Territory. Some species of introduced flora are declared weeds under the NT Weeds Management Act because of the environmental and/or economic harm they can cause. Class A weeds are to be eradicated by landowners and occupiers. Class B weeds must have their growth and spread controlled by landowners and occupiers. The remaining introduced flora species are referred to as environmental weeds. The Commonwealth Government has also categorised some species as Weeds of National Significance (WoNS). The main weed of concern within the project footprint is Buffel Grass (*Cenchrus ciliaris*), which is not a declared species but is listed as a category 2 species in the Alice Springs Regional Weeds Strategy 2021- 2026 (DEPWS 2021) due to its potential impacts on biodiversity and fire risk. Bitter Paddymelon (*Citrullus colocynthis*) was also present at many sites however this is a lower impact environmental weed.

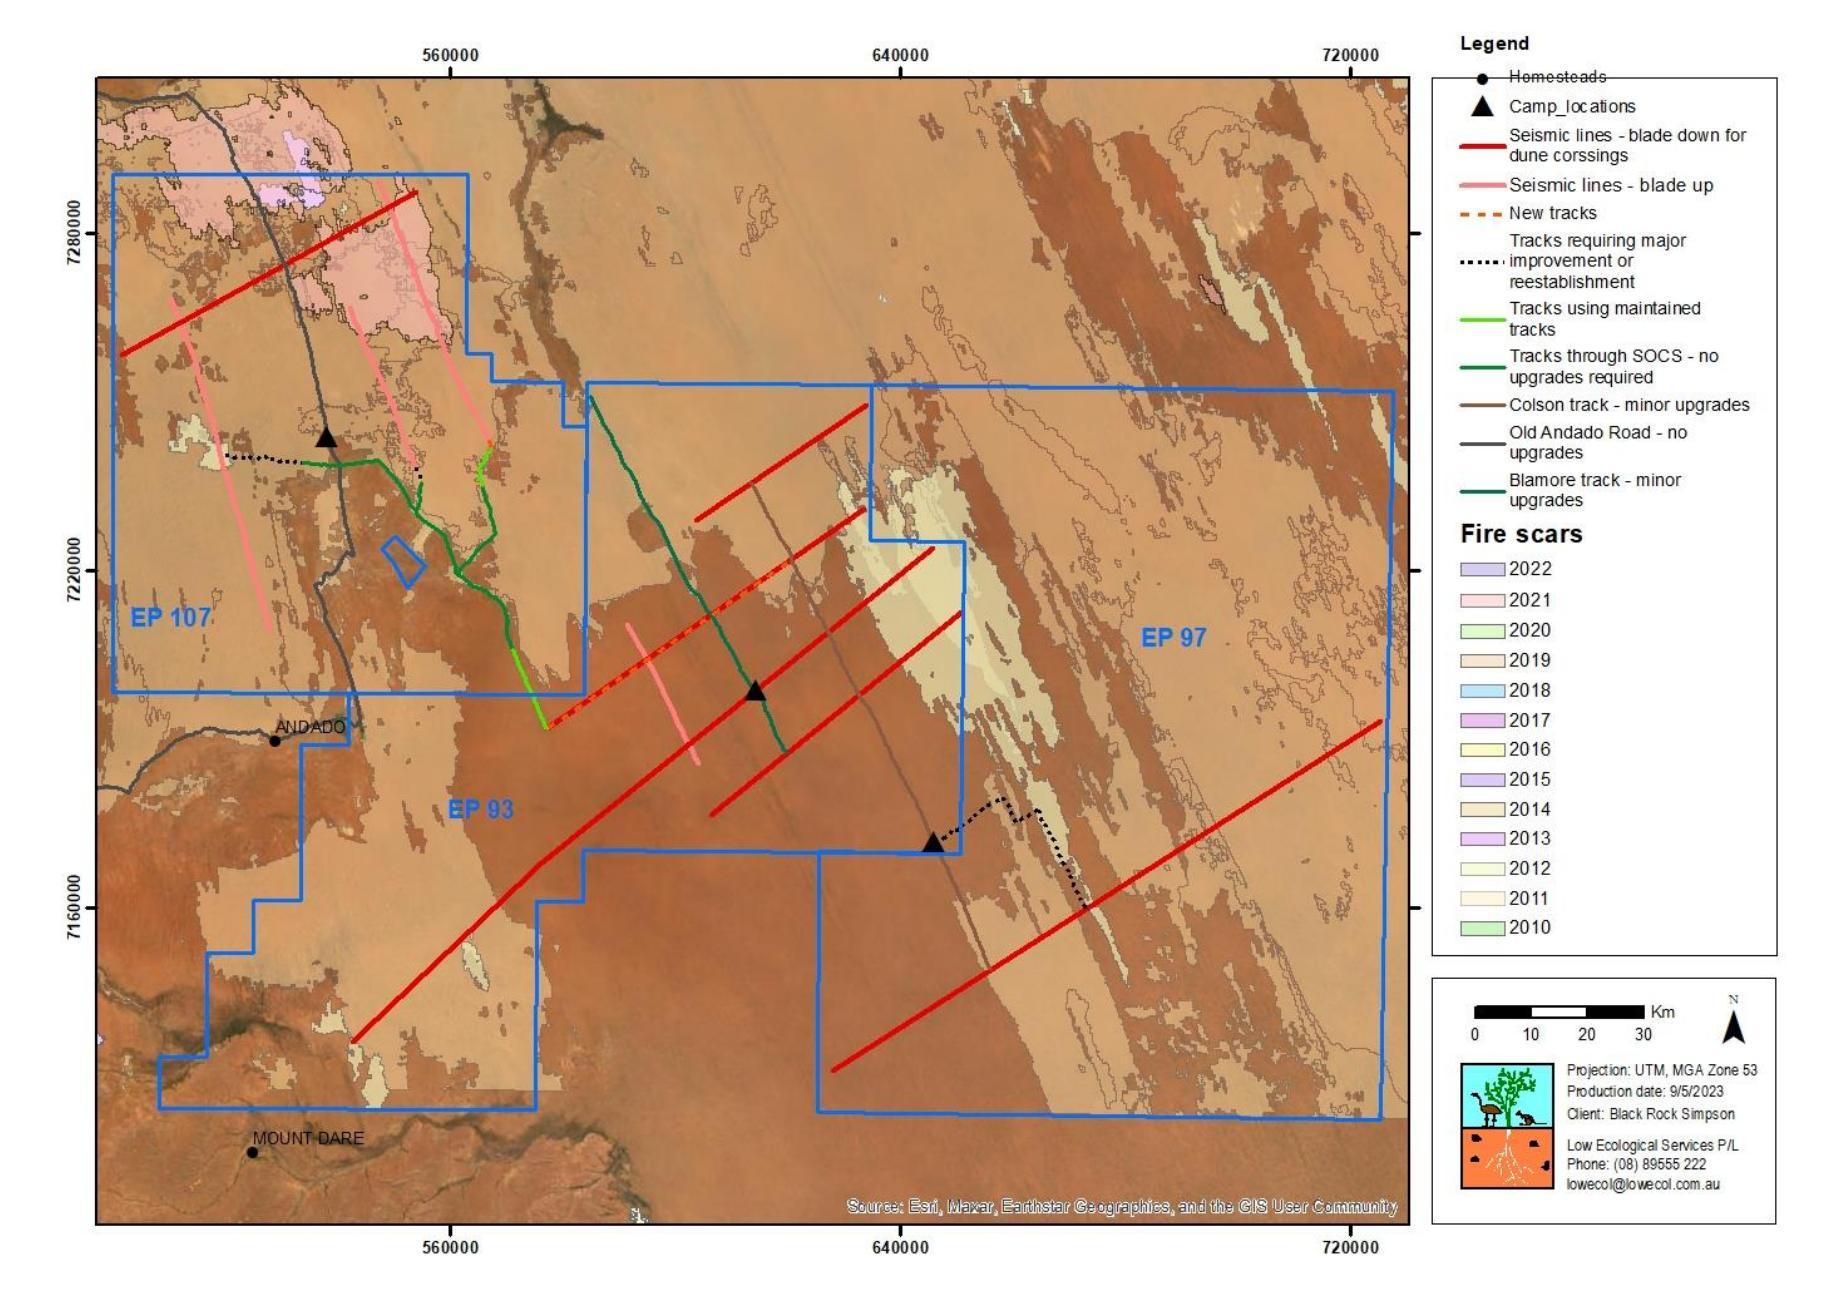
Figure 5-3 Fire history of the project area

Fires are a frequent occurrence in the Simpson desert and are often related to periods of above annual rainfall. According to fire history and fire scar data in Northern Australia and Rangelands Fire Information, a significant portion of the project area burnt in 2011 in fires which covered much of the Simpson desert Figure 5-3). The most recent fires occurred in the Northern section of EP107 in 2020 and 2021, although these fires were significantly smaller than the fires which occurred in 2011. Fuel loads across the region were moderate to high during the field survey. Fuel loads were higher in areas with perennial vegetation, while areas of annual vegetation were less significant.

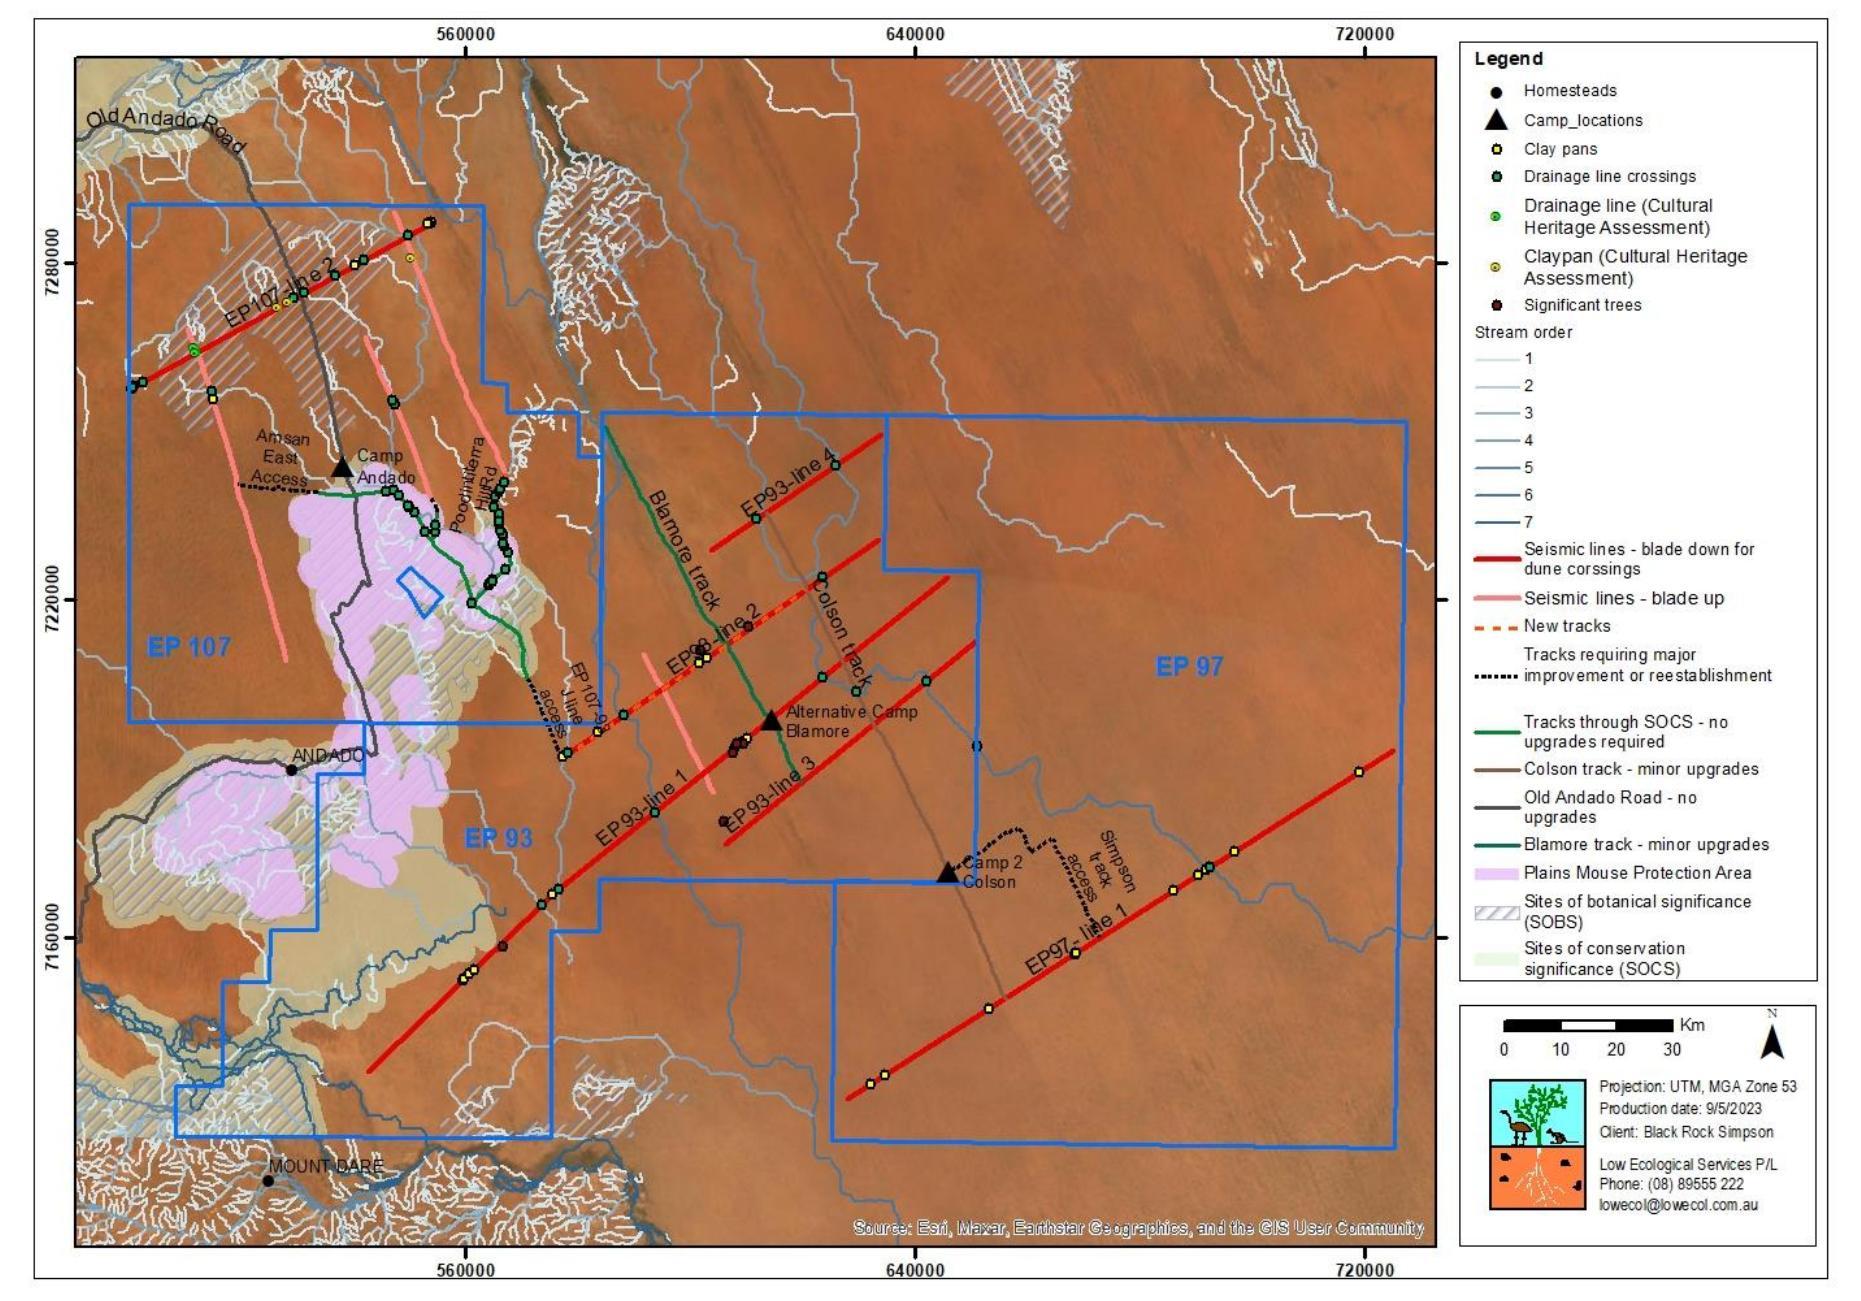
Figure 7-1. Drainage-line crossings, clay pans and significant trees to avoid.

- Nine clay pans were noted during the survey of this line and three artefacts were identified adjacent to the seismic line in one of these areas, shown in map (Figure 7.1).

- There are three drainage lines which intersect the seismic line. The most easterly line is associated with the Hale river flood out and the recorded claypans. This site was inspected during the survey. It is recommended to avoid large trees associated with clay pans and drainage systems. The two western drainage lines are stream order three and four respectively. These streams were surveyed and do not present erosion issues as they are non-perennial and are associated with broad dune swales and clay pans. Clay pans can be skirted around, and large trees avoided.

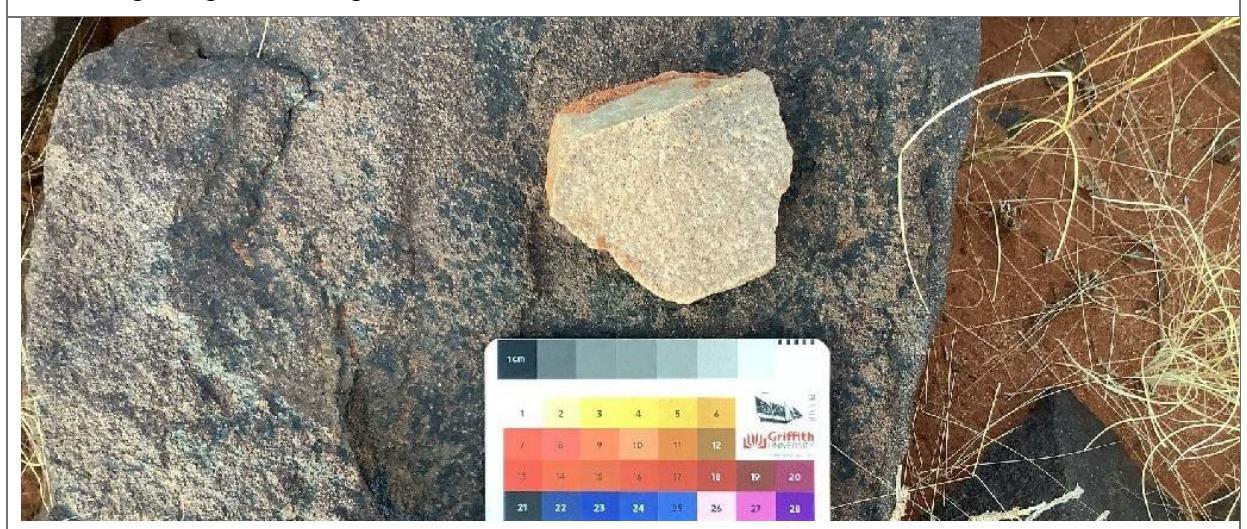
Site Location	
Seismic Line: EP93-Line1	Date: 5/18/2022
Easting:	Northing:
Transect ID: CHSA037_EP93-Line 1	Proximity to Work Areas: 280m south of seismic line

Archaeological Description				
Site Type: Isolated Artefact				
Site Access Status: Unrestricted				
Site Description: 1 flake (Silcrete) on margin of claypan				
Area (m <sup>2</sup> ): <1m2				
Artefact Types: 1 x Flake				
Raw Materials: Silcrete				
Site Structure: Surface only				
Condition: Good	Disturbance Factors: Minor evidence for livestock disturbance.

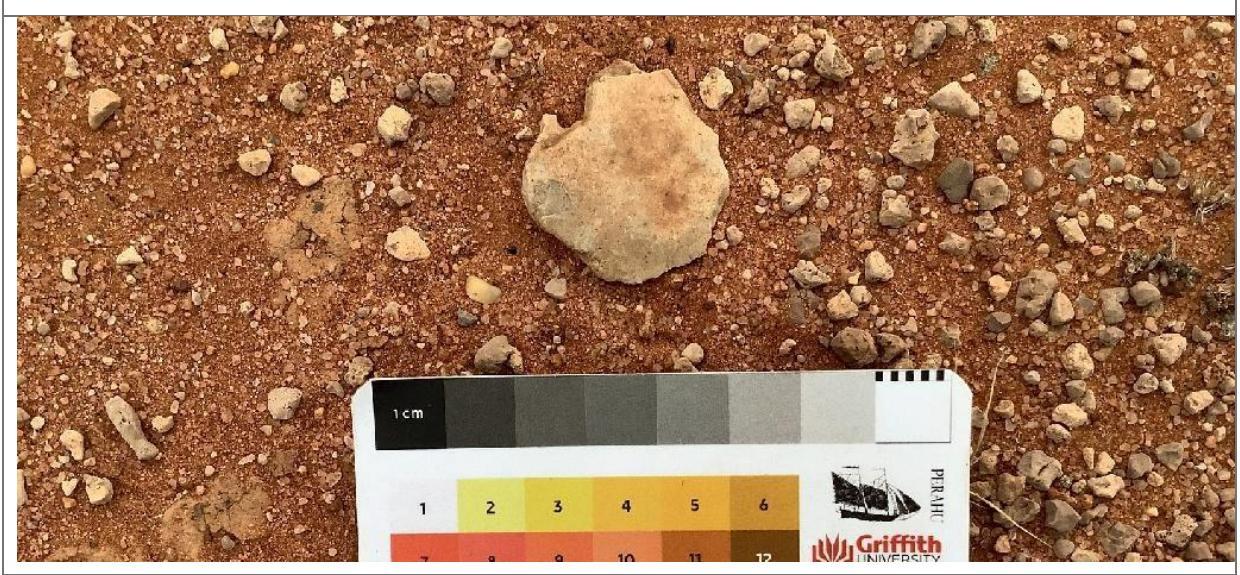
Site Location	
Seismic Line: EP93-Line1	Date: 5/18/2022
Easting:	Northing:
Transect ID: CHSA037_EP93-Line 1	Proximity to Work Areas: 280m south of seismic line

Archaeological Description				
Site Type: Isolated Artefact				
Site Access Status: Unrestricted				
Site Description: 1 flake (Silcrete) on margin of claypan				
Area (m <sup>2</sup> ): <1m2				
Artefact Types: 1 x Flake				
Raw Materials: Silcrete				
Site Structure: Surface only				
Condition: Good	Disturbance Factors: Minor evidence for livestock disturbance.

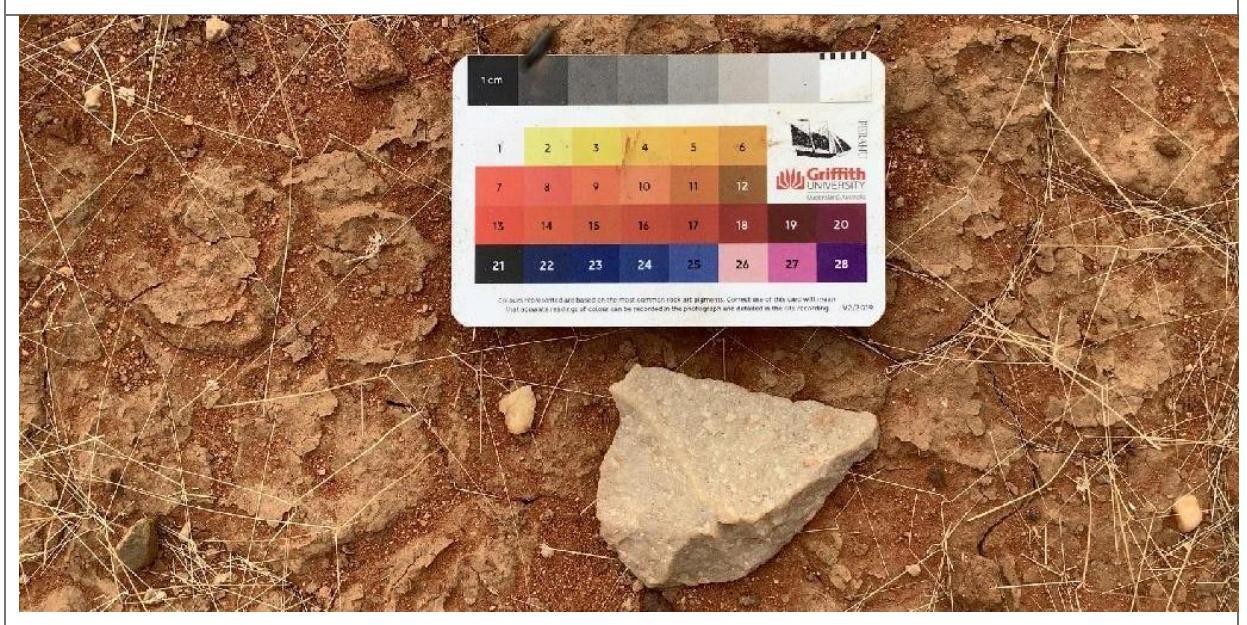
Site Location	
Seismic Line: EP107-Line2	Date: 5/24/2022
Easting:	Northing:
Transect ID: CHSA002_EP107-Line 1	Proximity to Work Areas: 110m south of seismic line

Archaeological Description	
Site Type: Isolated Artefact	
Site Access Status: Unrestricted	
Site Description: 1 x core (Silcrete)	
Area (m <sup>2</sup> ): <1m2	
Artefact Types: 1 x Core	
Raw Materials: Silcrete	
Site Structure: Surface only	
Condition: Good	Disturbance Factors: Med-heavy livestock disturbance

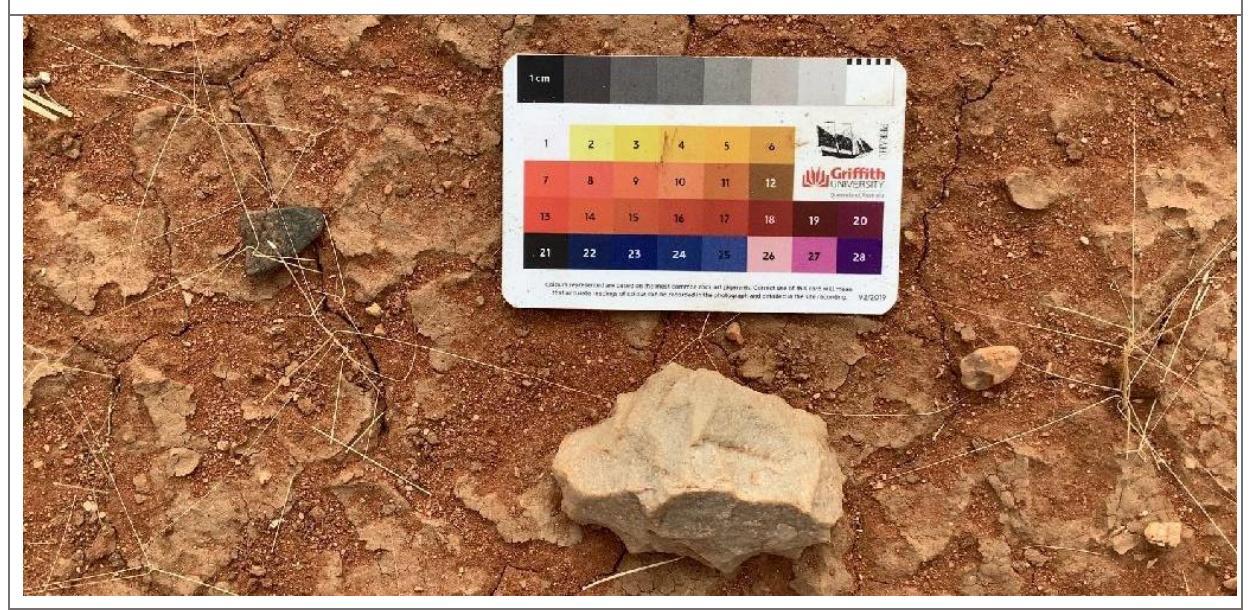
Site Location	
Seismic Line: EP107-Line5	Date: 5/23/2022
Easting:	Northing:
Transect ID: EP107-Line 5_Stop 3	Proximity to Work Areas: 250m west of seismic line

Archaeological Description	
Site Type: Isolated Artefact	
Site Access Status: Unrestricted	
Site Description: Multi-tool axe/grind plate (iron stone; incomplete, rhomboid - 7x4(blade)x7x1cm/ 1.5cm wide in section), retouched chert flake and silcrete flake recorded in a 5mÅ <sup>2</sup> area. No other ch observed in a cursive search (30mÅ <sup>2</sup> ).	
Area (m <sup>2</sup> ): <5m2	
Artefact Types: 1 x RT Flake, 1 x Flake, 1 x Axe, 1	
Raw Materials: Ironstone, Chert & Silcrete	
Site Structure: Surface only	
Condition: Good	Disturbance Factors: Nil

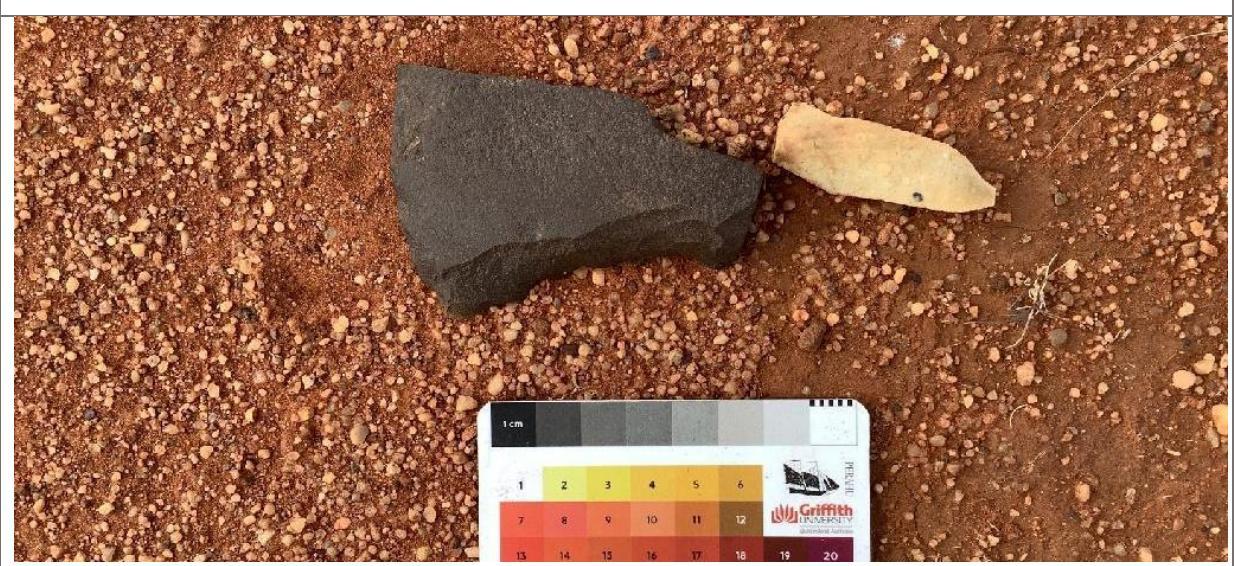
Site Location	
Seismic Line: EP107-Line2	Date: 5/24/2022
Easting:	Northing:
Transect ID: CHSA002_EP107-Line 1	Proximity to Work Areas: 75m north of seismic line

Archaeological Description	
Site Type: Isolated Artefact	
Site Access Status: Unrestricted	
Site Description: 1 x whole flake (Silcrete)	
Area (m <sup>2</sup> ): <1m2	
Artefact Types: 1 x Flake	
Raw Materials: Silcrete	
Site Structure: Surface only	
Condition: Good	Disturbance Factors: Livestock disturbance.

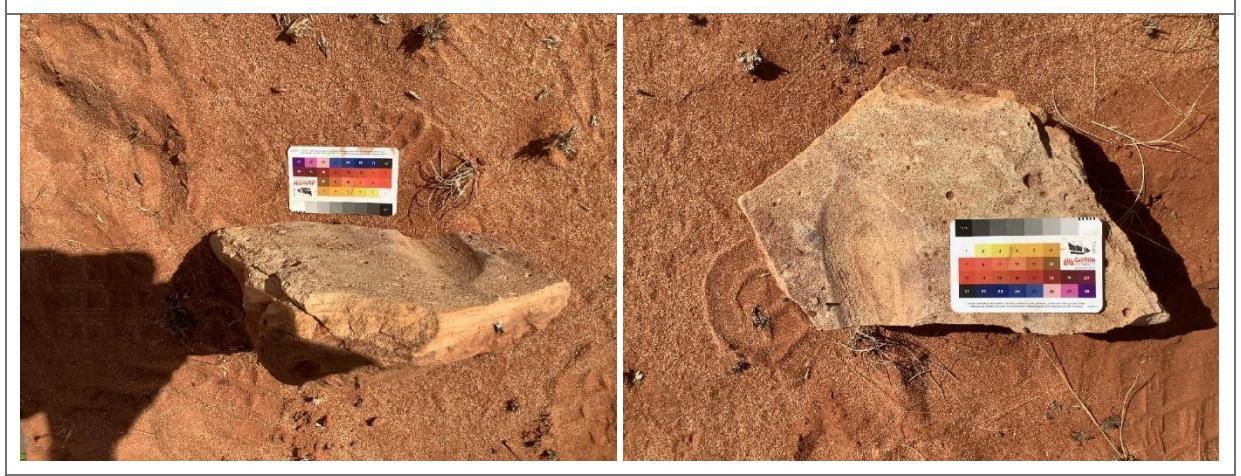
Site Location	
Seismic Line: EP107-Line2	Date: 5/24/2022
Easting:	Northing:
Transect ID: CHSA002_EP107-Line 1	Proximity to Work Areas: 20m north of seismic line

Archaeological Description		
Site Type: Isolated Artefact		
Site Access Status: Unrestricted		
Site Description: Manuport halfway up dune flank. Heat fractured. Potentially part of a hearth.		
Area (m <sup>2</sup> ): <1m2		
Artefact Types: 1 x Manuport		
Raw Materials: Sandstone		
Site Structure: Surface only		
Condition: Good	Disturbance Factors: Livestock disturbance.
