NORTHERN TERRITORY

ANNUAL REPORT 2019-20

In accordance with section 29(a) of the *Pastoral Land Act 1992*, I hereby submit for your information and presentation to Parliament, the Pastoral Land Board Annual Report into the land condition of the NT Pastoral Estate for the reporting period 1 October 2019 to 31 December 2020.

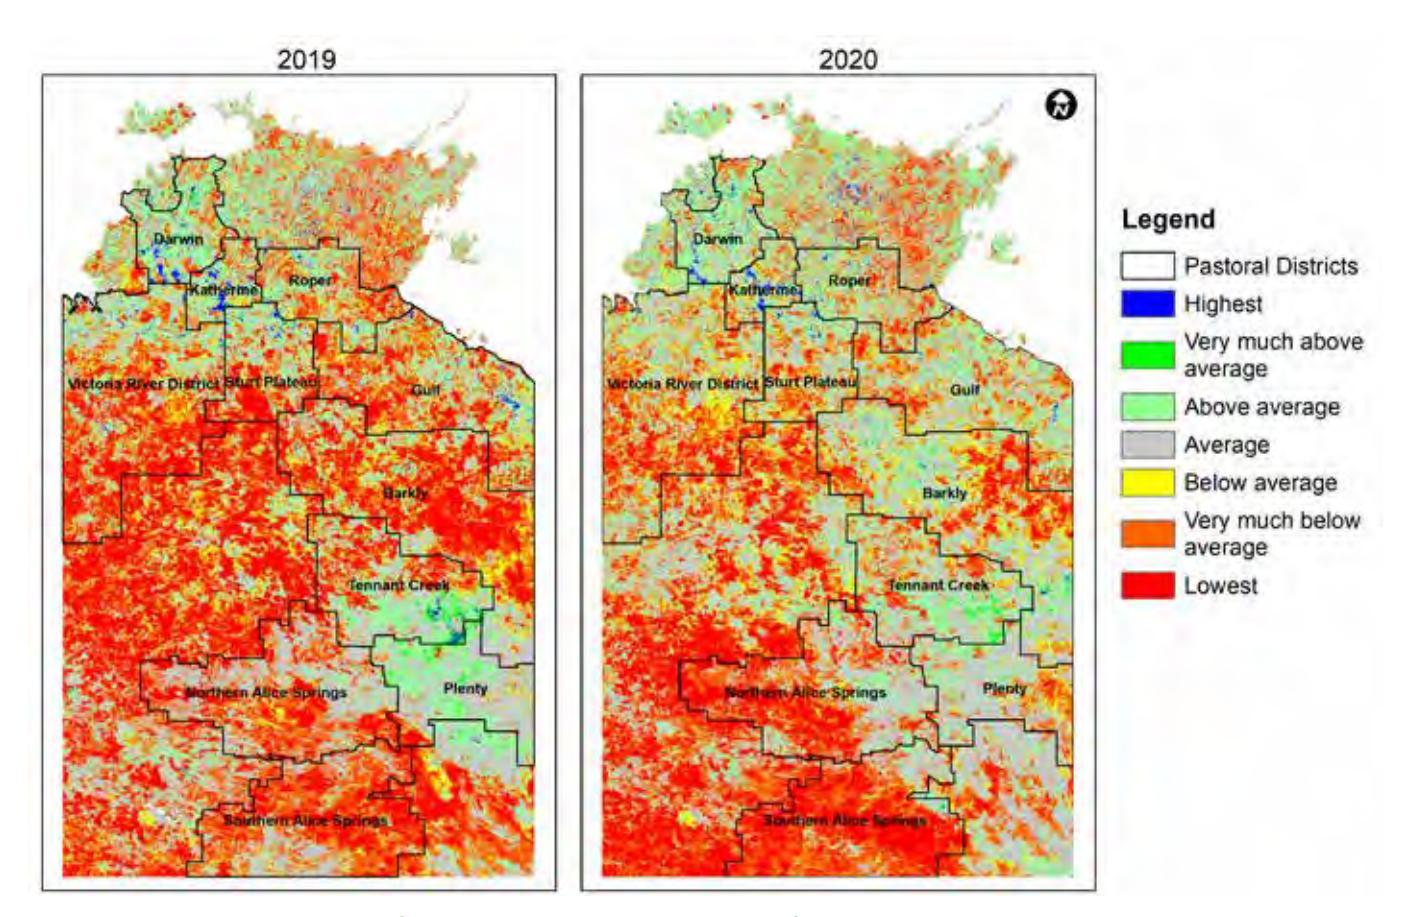
Figure 2: Decile ranked rainfall for the October 2019 to September 2020 period (Source Bureau of Meteorology)

Seasonal conditions for 2019-20, based on rainfall amount compared with the long-term record (Figure 2), were:

- Below-average to lowest on record for large areas of the Northern Territory.
- Most of the northern Barkly, Sturt Plateau, Northern Alice Springs, and the southern VRD Districts had lowest on record conditions.
- Most of the Roper, Southern Alice Springs, and Tennant Creek Pastoral Districts had below average rainfall.
- The Plenty Pastoral District had average to above-average rainfall and the central and western part of the Gulf Pastoral District had average conditions.

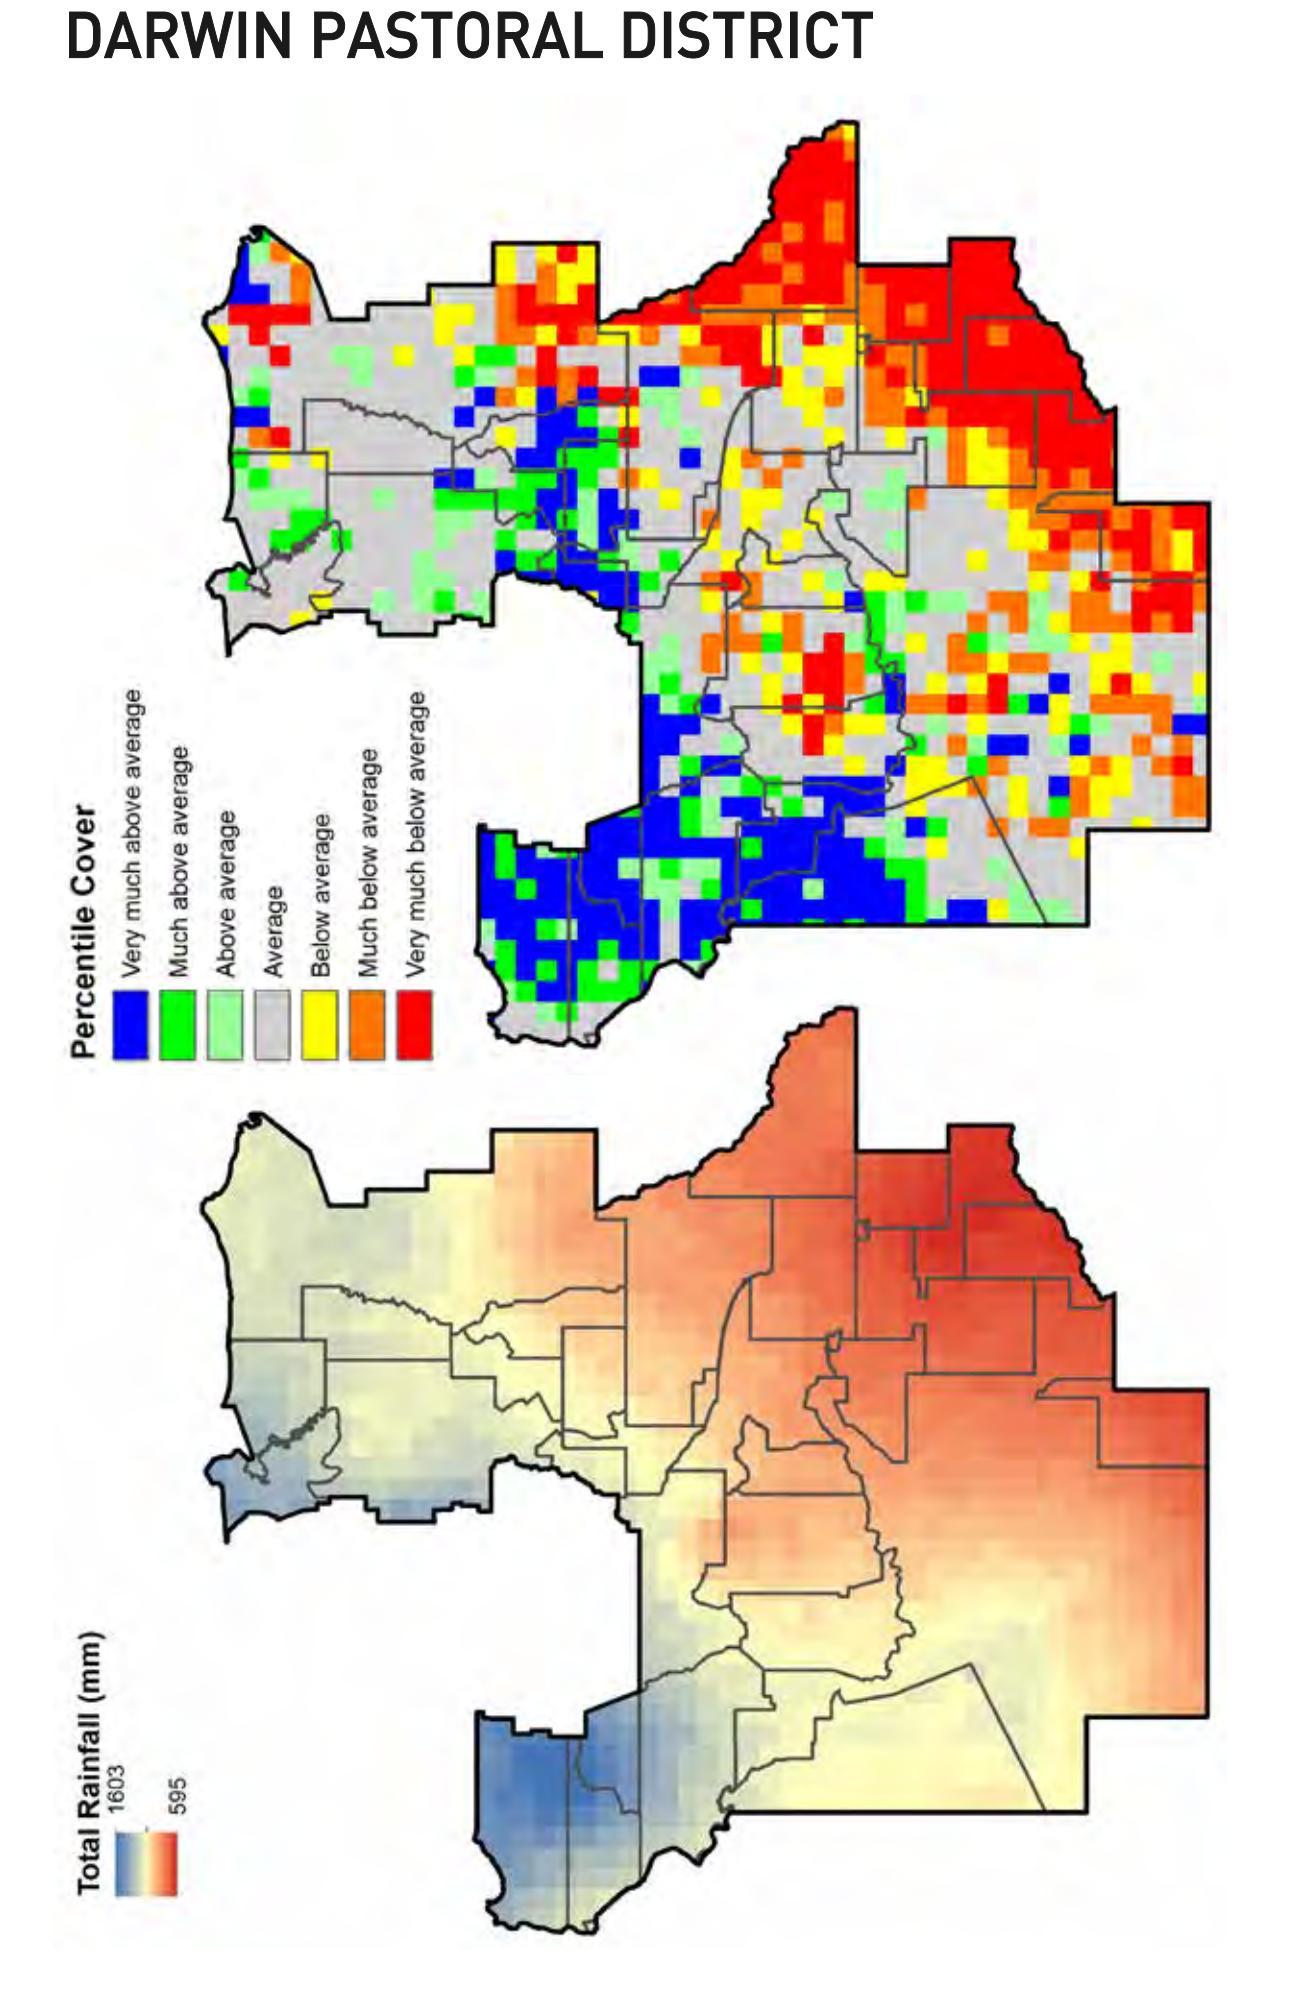
Figure 5: Maps of seasonal quality. Left, spatially interpolated rainfall, October 2019 to September 2020; right, AussieGRASS-modelled pasture growth for the 2019-20 summer (wet season) period as a percentage of previous summers.

Modelled pasture growth over the last summer was slightly below the long term average based on the spatial mean (Table 4). The spatial distribution of modelled pasture growth generally related to the distribution of total rainfall (Figure 5).

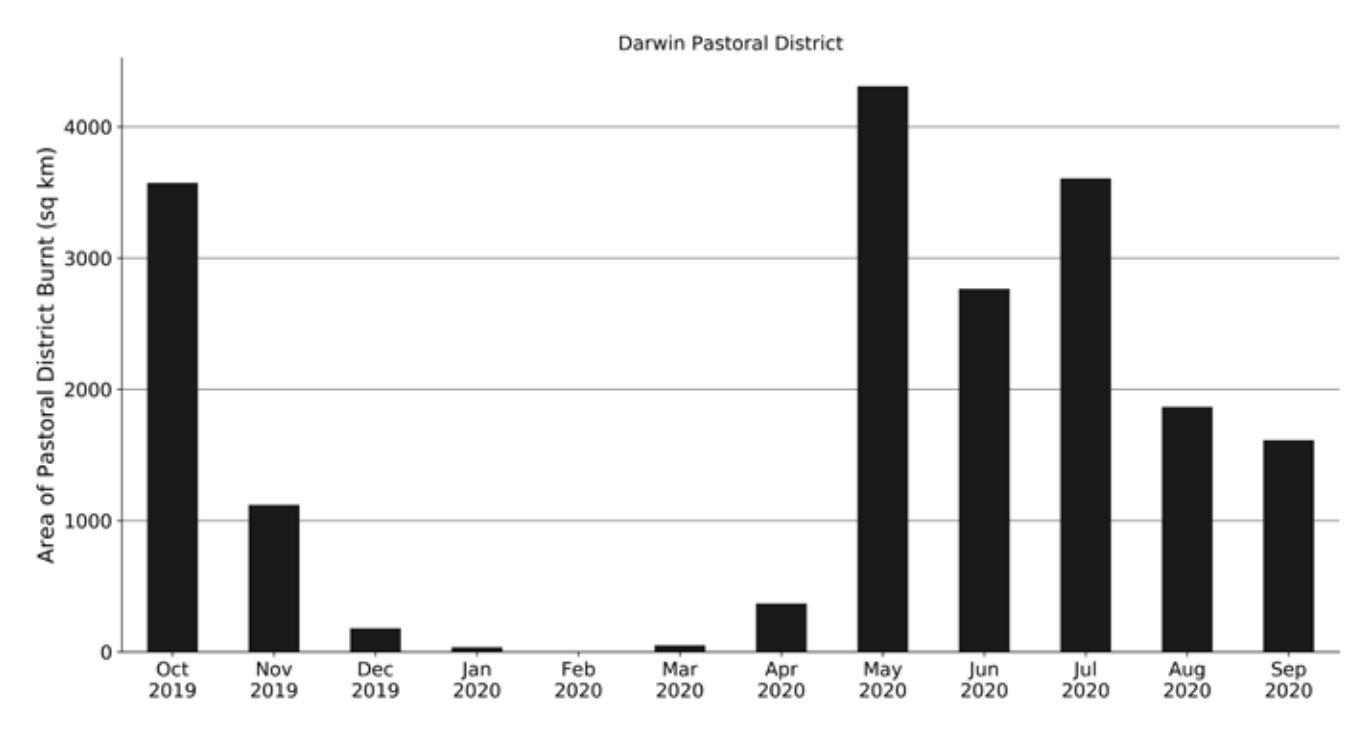
Figure 6: Monthly area burnt (km²) in the Darwin Pastoral District between October 2019 and September 2020.

The North Australian and Rangelands Fire Information website (<u>firenorth.org.au/nafi3/</u>) reports that 19 484km² burnt (53% of Darwin Pastoral District) between October 2019 and September 2020 (Figure 6). This was relatively similar to the previous two reporting periods (October 2018 to September 2019 and October 2017 to September 2018), which recorded areas of 17 218km² and 18 791km² burnt.

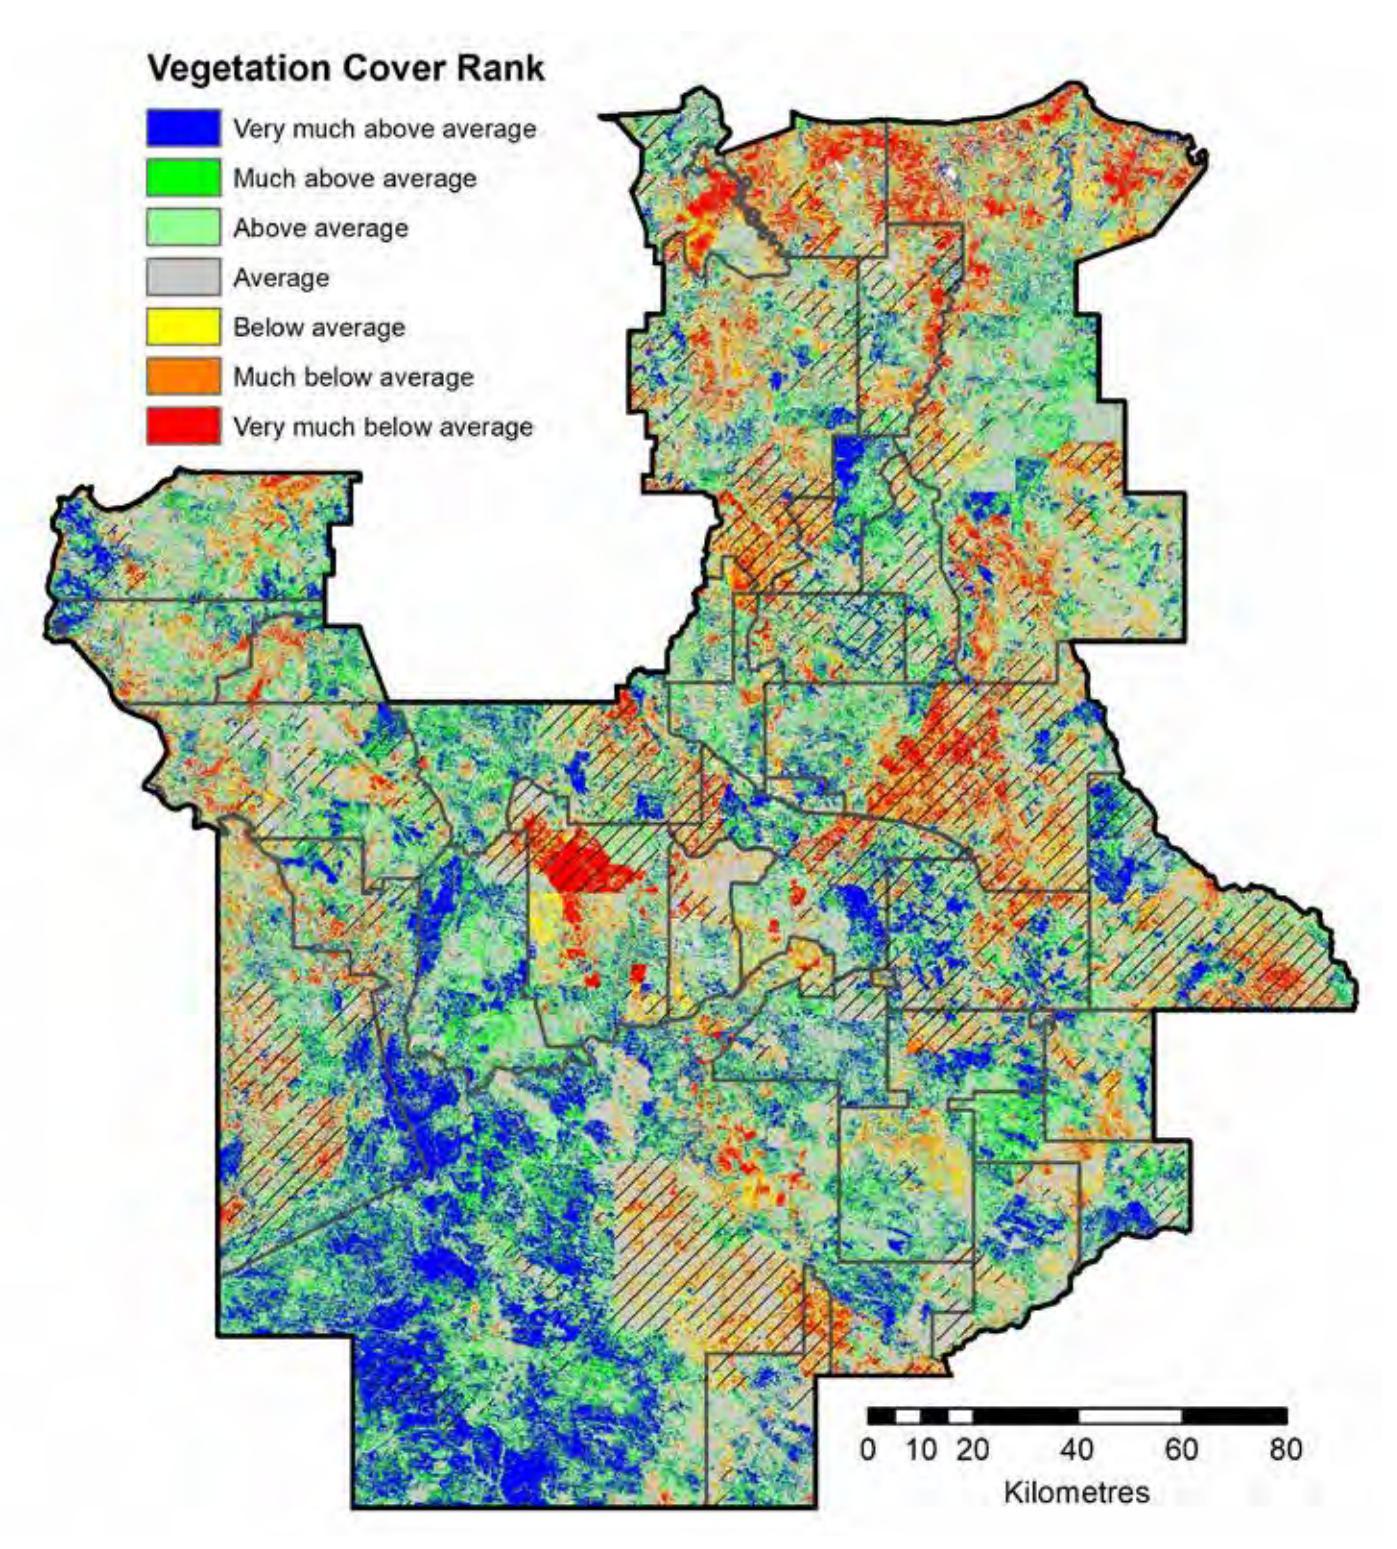
Figure 7: Rank of the amount of remotely-sensed vegetation cover present from September to November 2020 against that for previous years back to 1988.

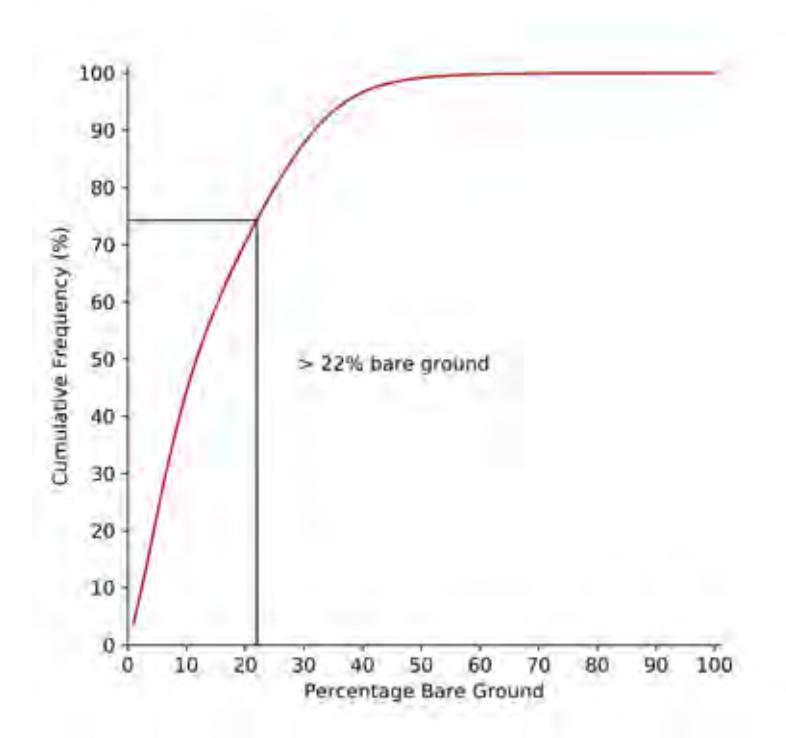
Figure 8: Percentage cumulative frequency of varying levels of bare ground in 30-m square Landsat pixels in the Darwin Pastoral District between September and November 2020. Areas with > 22% bare ground are mapped in Figure 9.

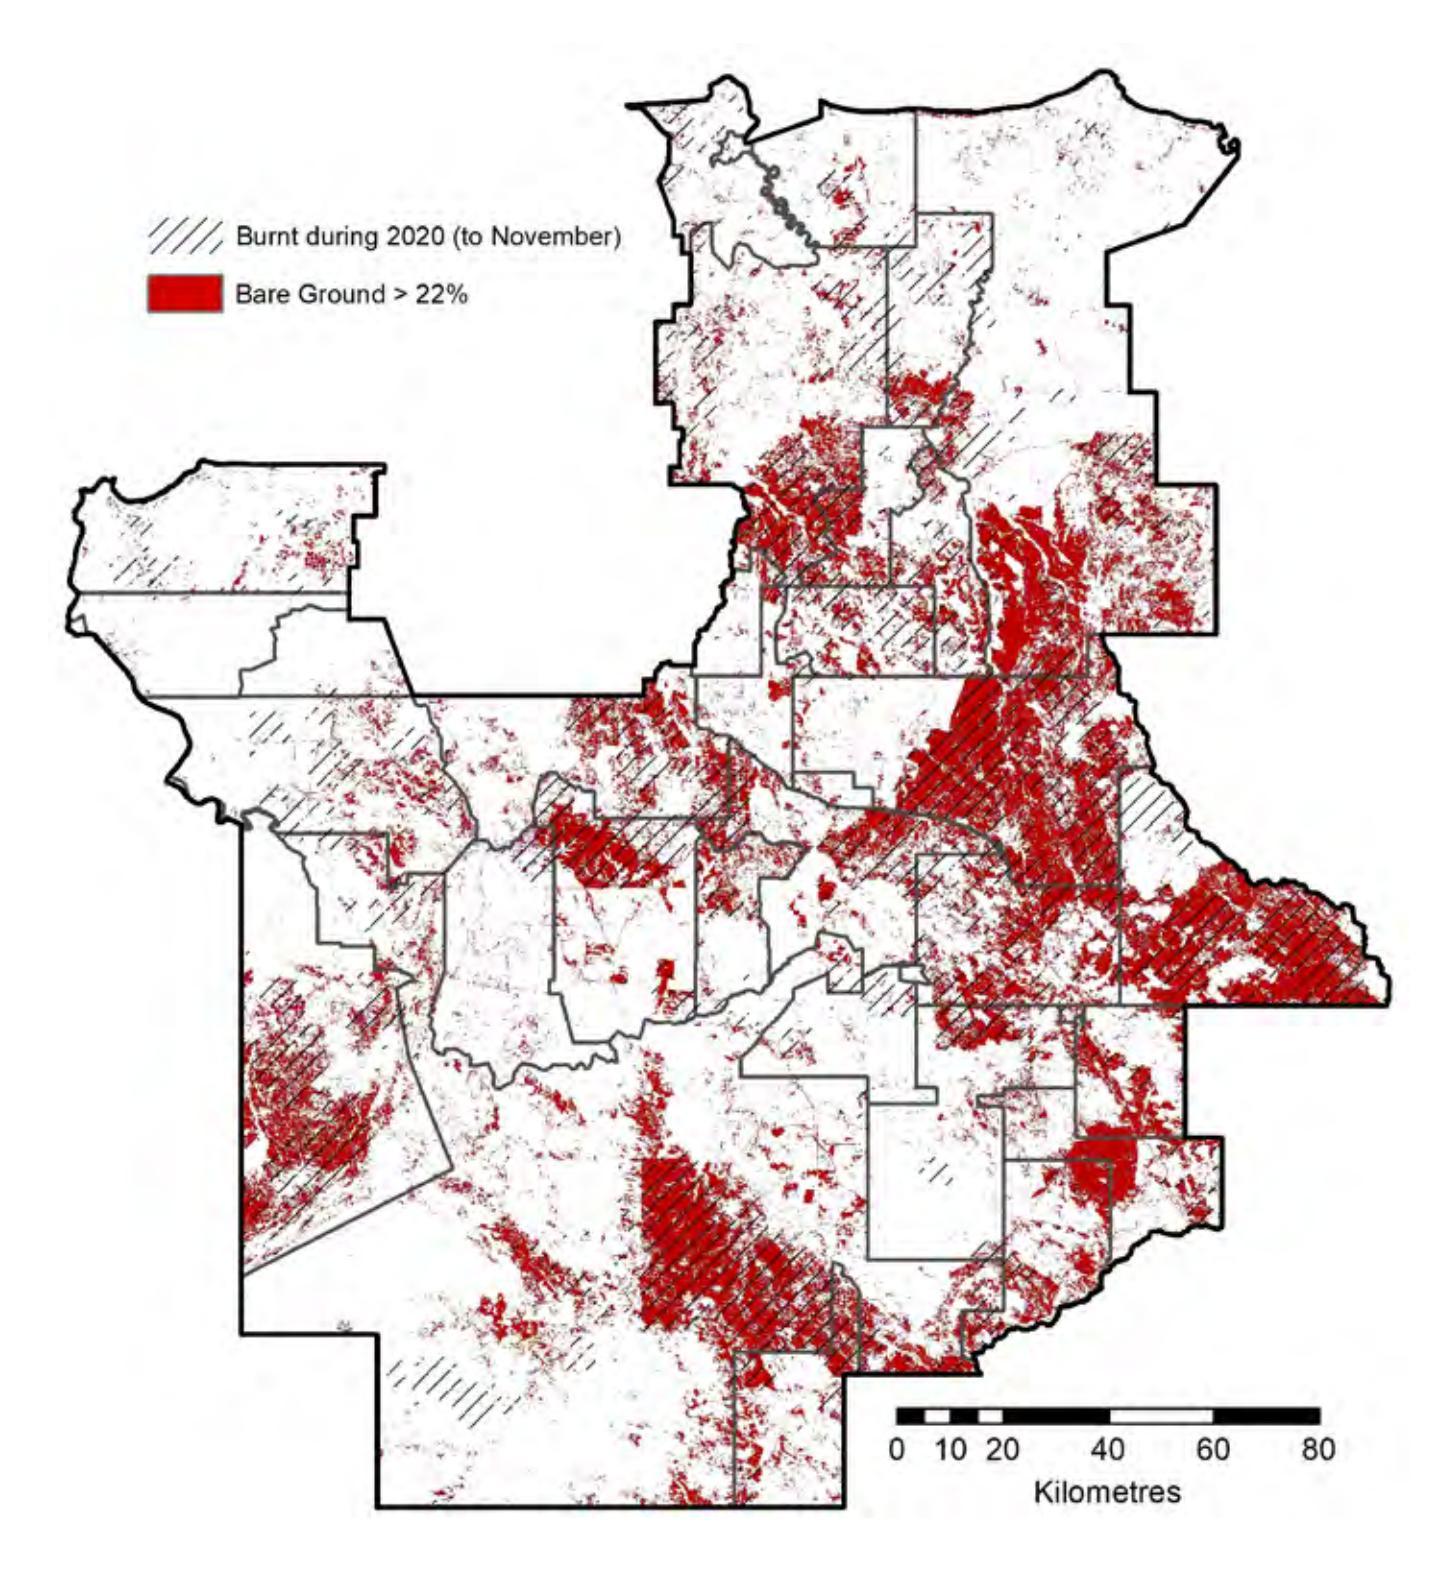
Figure 9: Parts of the Darwin Pastoral District having > 22% bare ground per Landsat pixel in late 2020. Areas burnt between January and November 2020 shown with diagonal lines. Note that the threshold level of bare ground used for mapping purposes varies between pastoral districts. It is selected to show at what level approximately 25% of the district is affected.

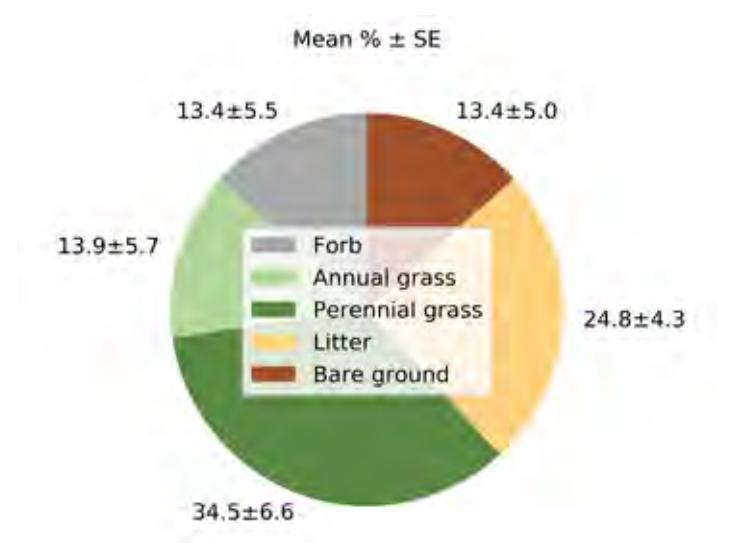
Figure 10: Mean percentage and standard error of measured components of vegetation cover in the ground layer from 12 sites on three pastoral leases in the Darwin Pastoral District.

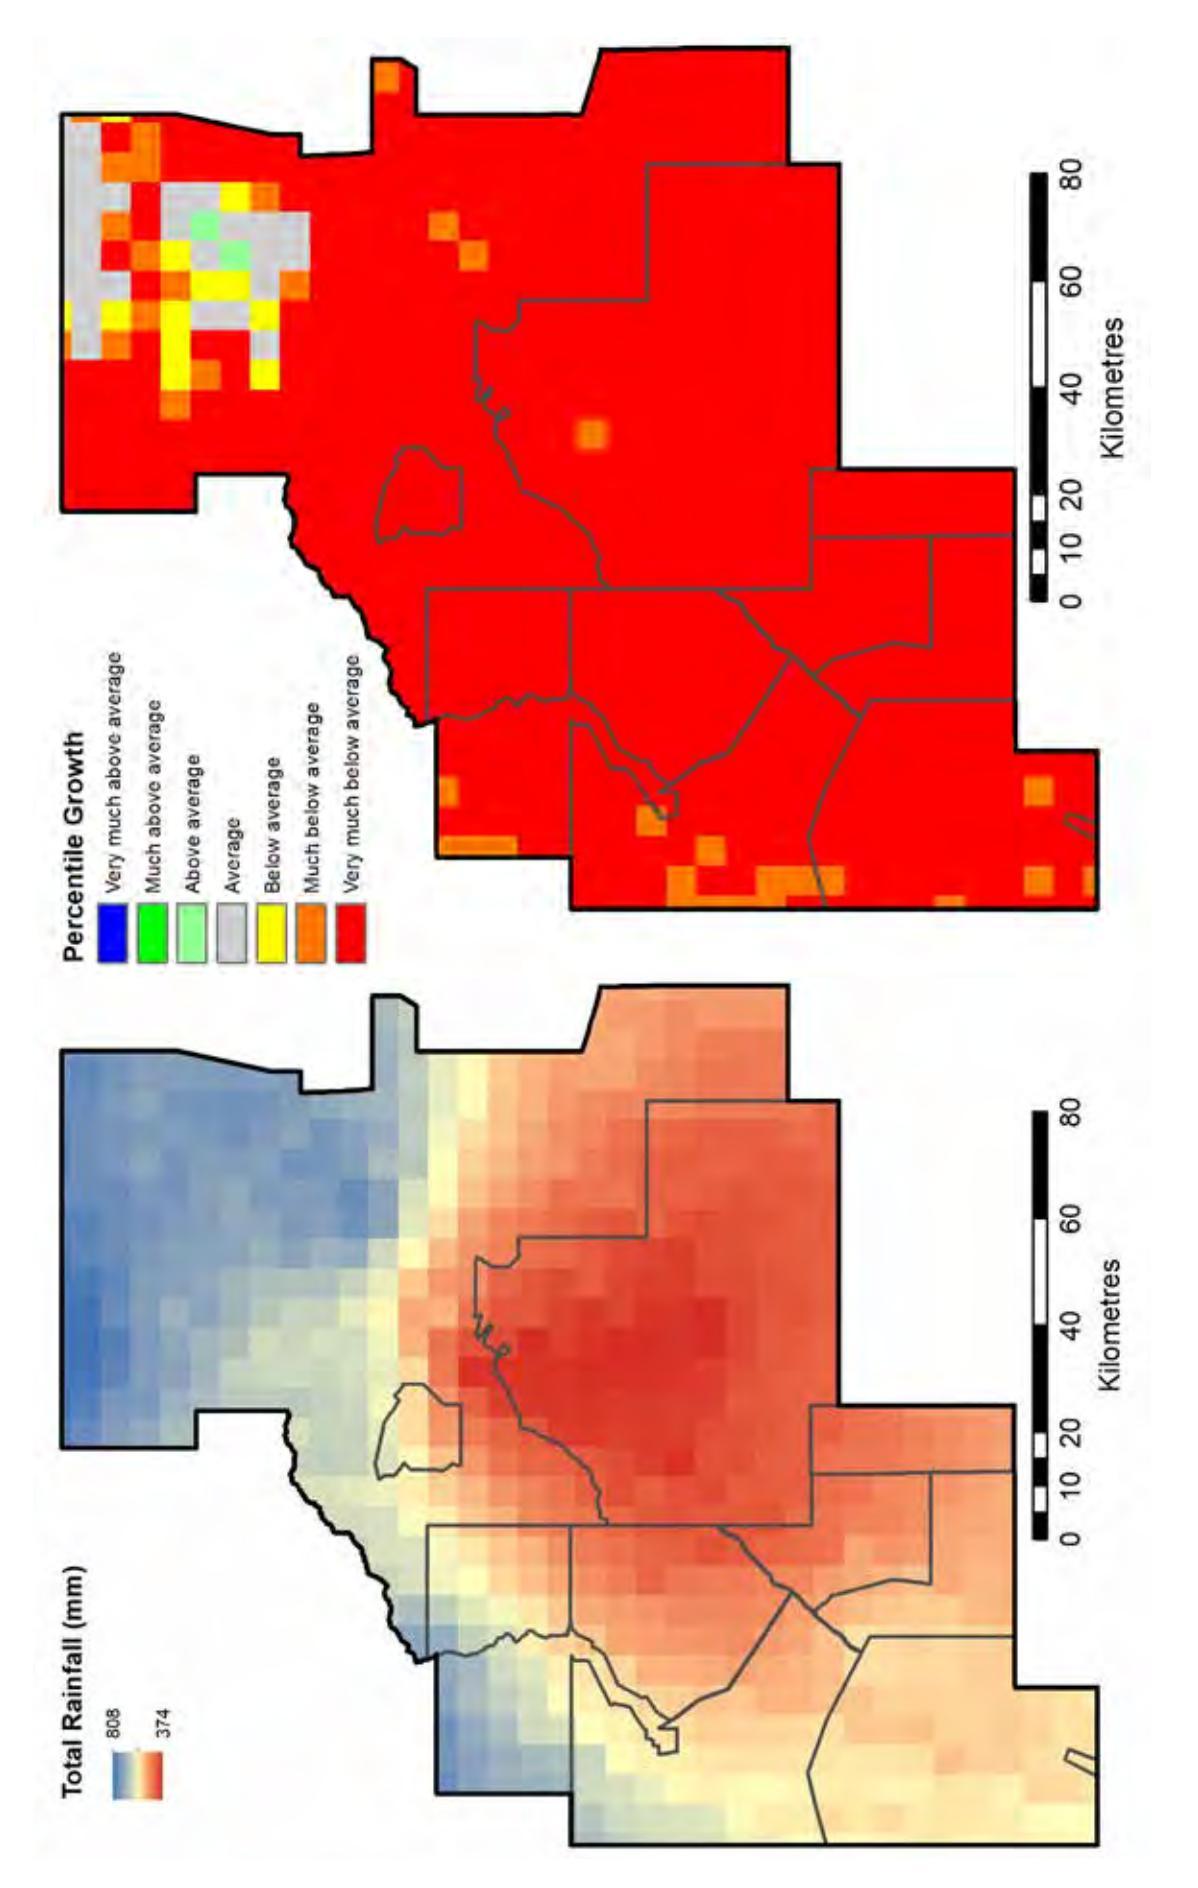
Figure 11: Maps of seasonal quality. Left, Spatially interpolated rainfall, October 2019 to September 2020; right, AussieGRASS-modelled pasture growth for the 2019-20 summer period as a percentage of previous summers. The grid cells on these maps are at 5km x 5km resolution (i.e. each square represents 25km²)

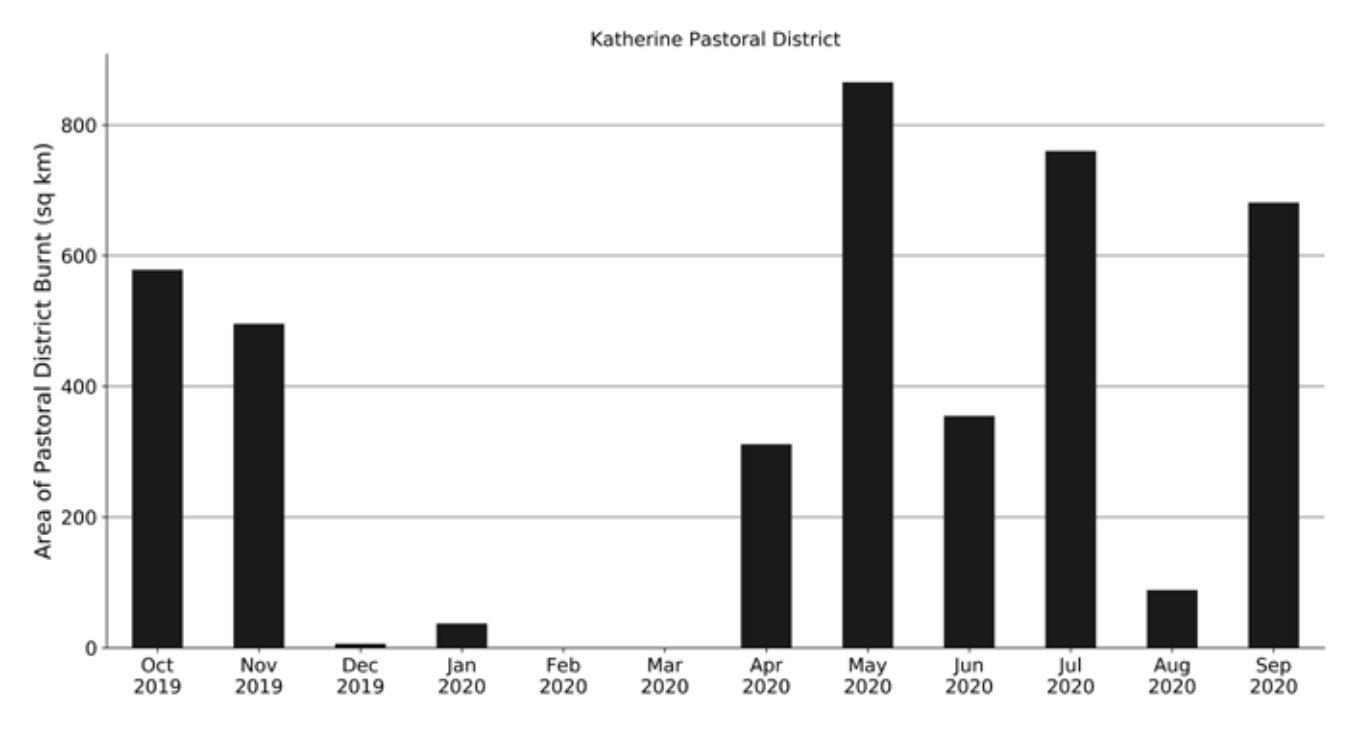
Figure 12: Monthly area burnt (km²) in the Katherine Pastoral District between October 2019 and September 2020.

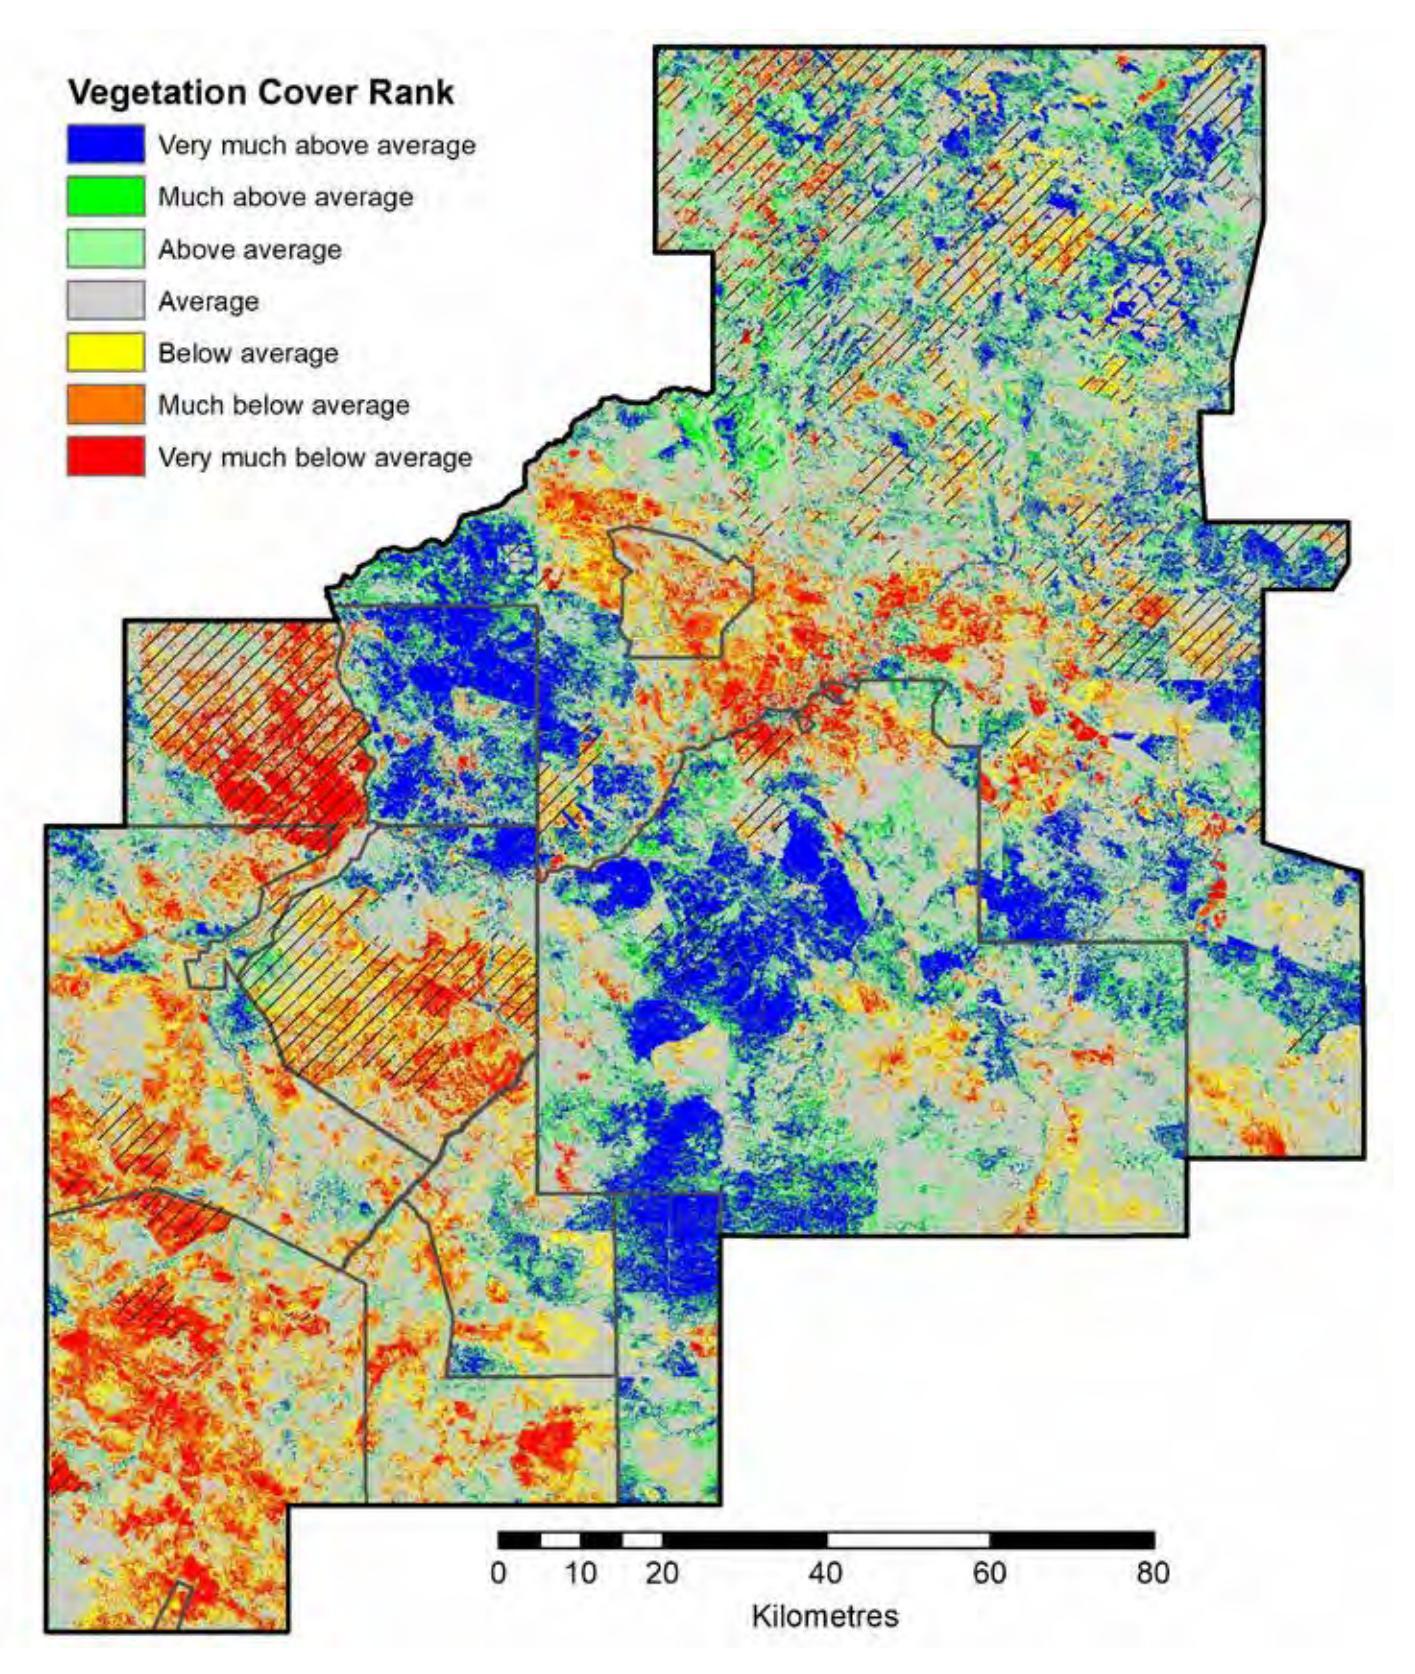
Figure 13: Rank of the amount of remotely-sensed vegetation cover present in late 2020 against that for previous years back to 1988. Diagonal lines show those areas burnt between January and November 2020.

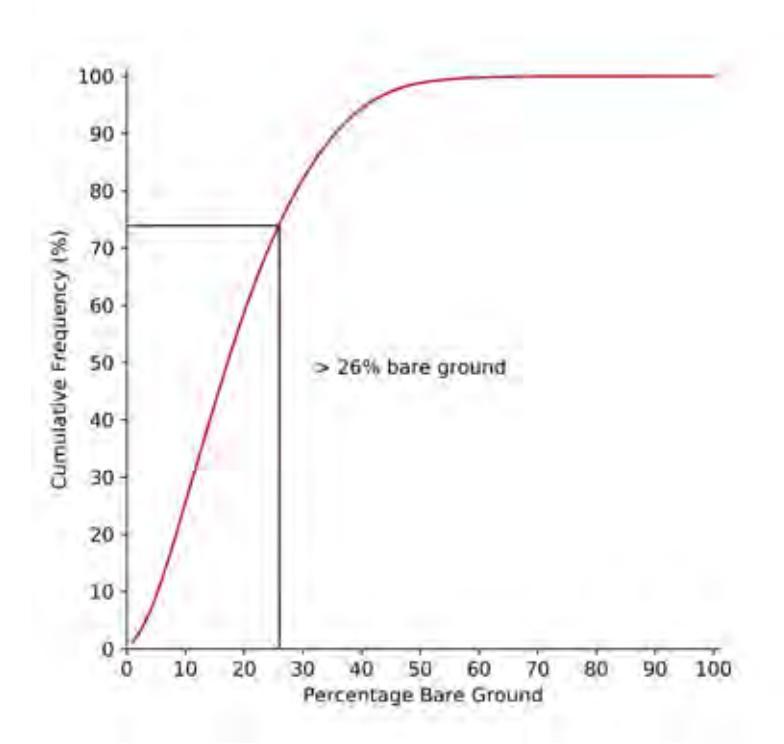
Figure 14: Percentage cumulative frequency of varying levels of bare ground in 30-m Landsat pixels in the Katherine Pastoral District between September and November 2020. Areas with greater than 26% bare ground are mapped in Figure 15.
KATHERINE PASTORAL DISTRICT

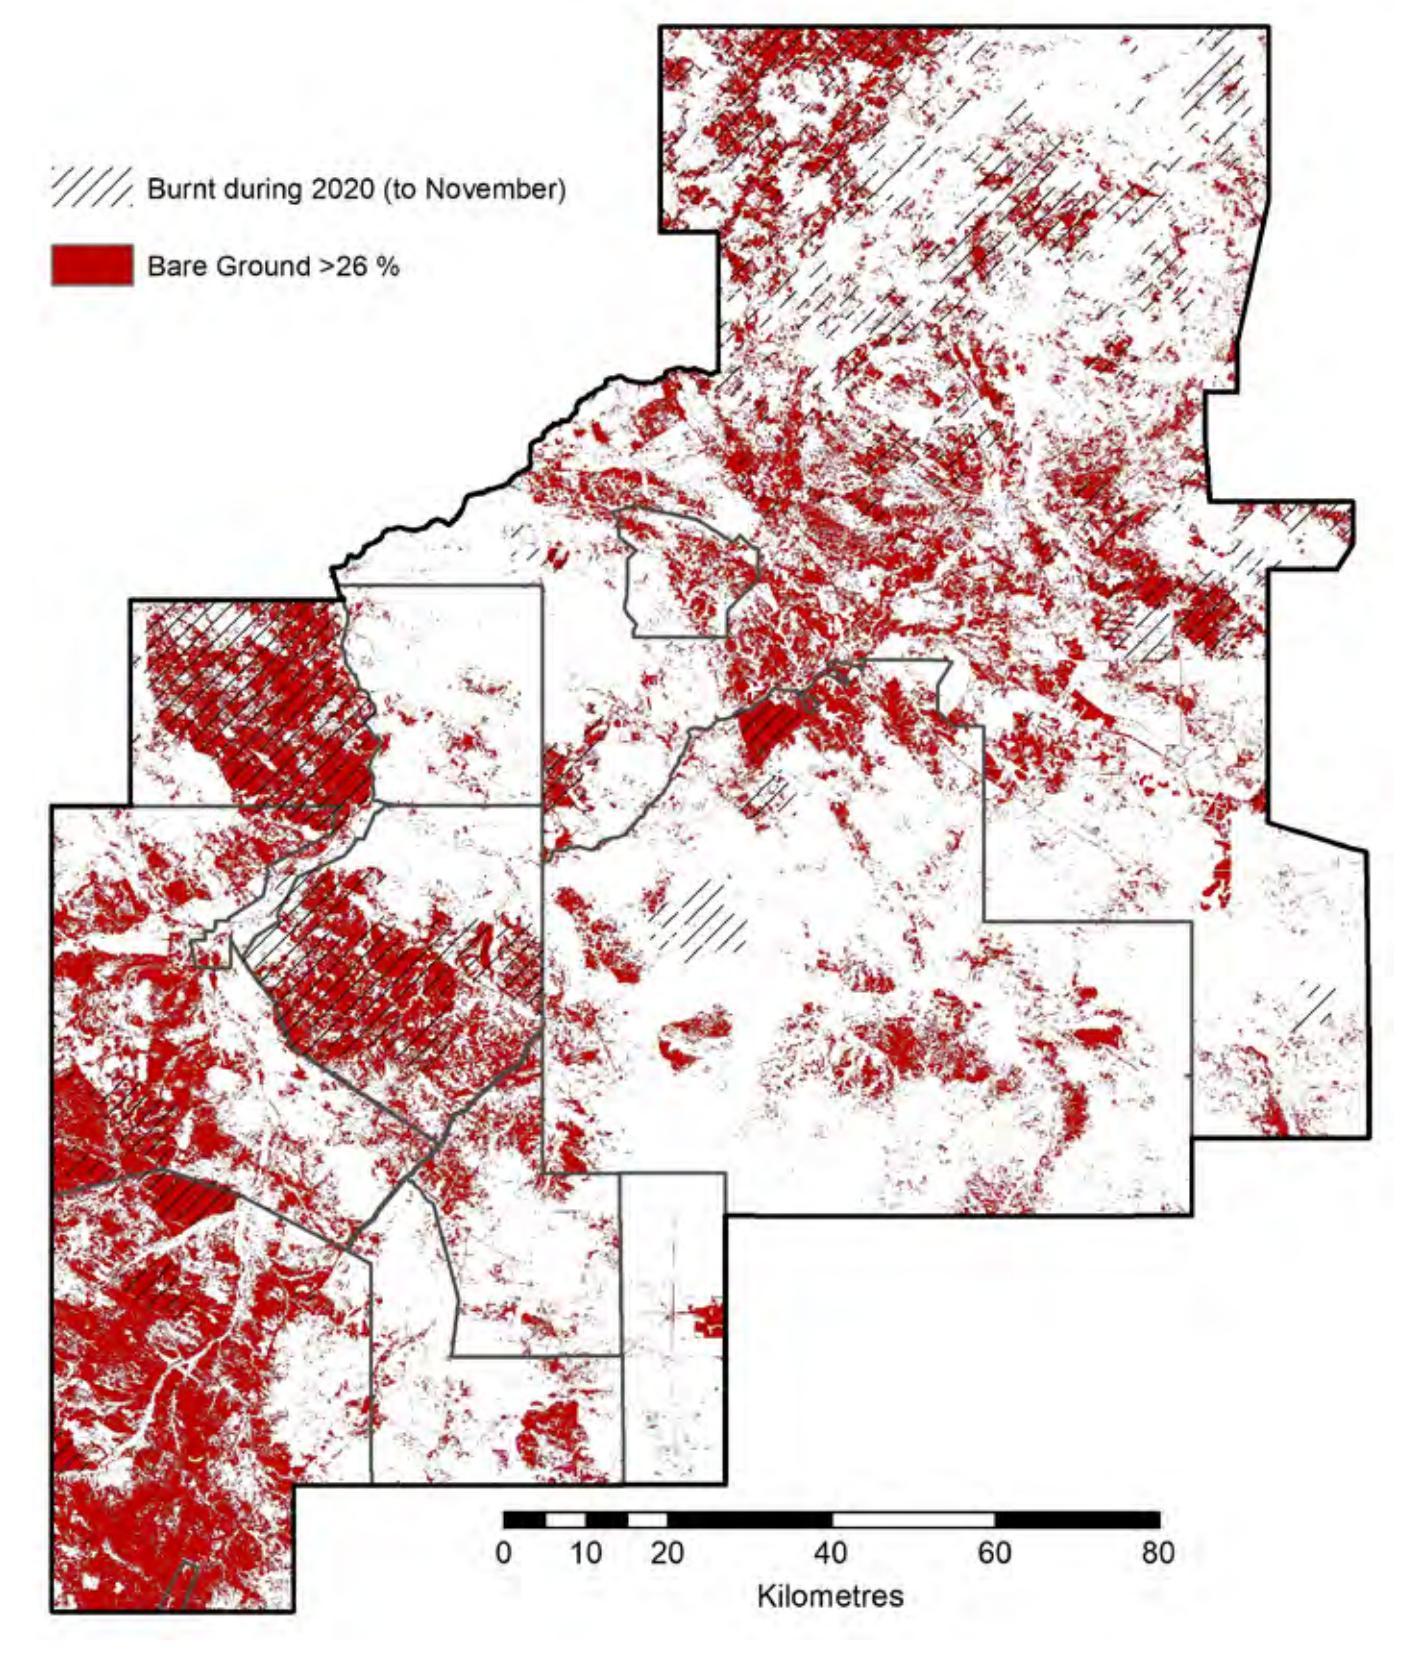
Figure 15: Parts of the Katherine Pastoral District having more than 26% bare ground per Landsat pixel in late 2020. Areas burnt between January and November 2020 shown with diagonal lines. Note that the threshold level of bare ground used for mapping purposes varies between pastoral districts. It is selected to show at what level approximately 25% of the district is affected.

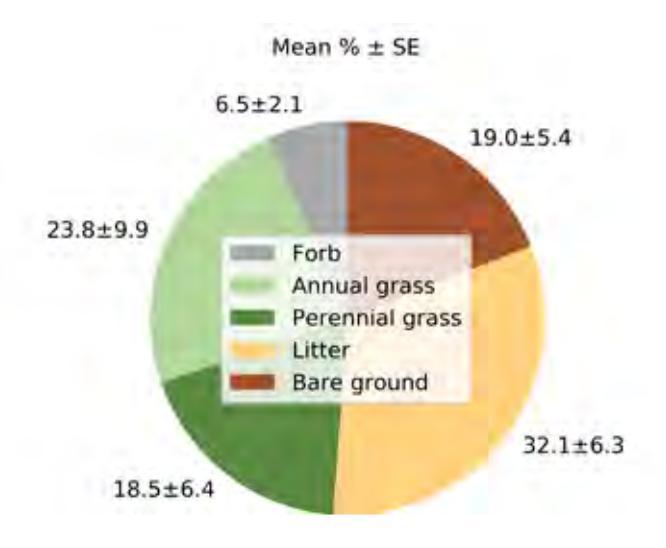
Figure 16: Mean percentage and standard error of measured components of vegetation cover in the ground layer from seven sites on two pastoral leases in the Katherine Pastoral District.

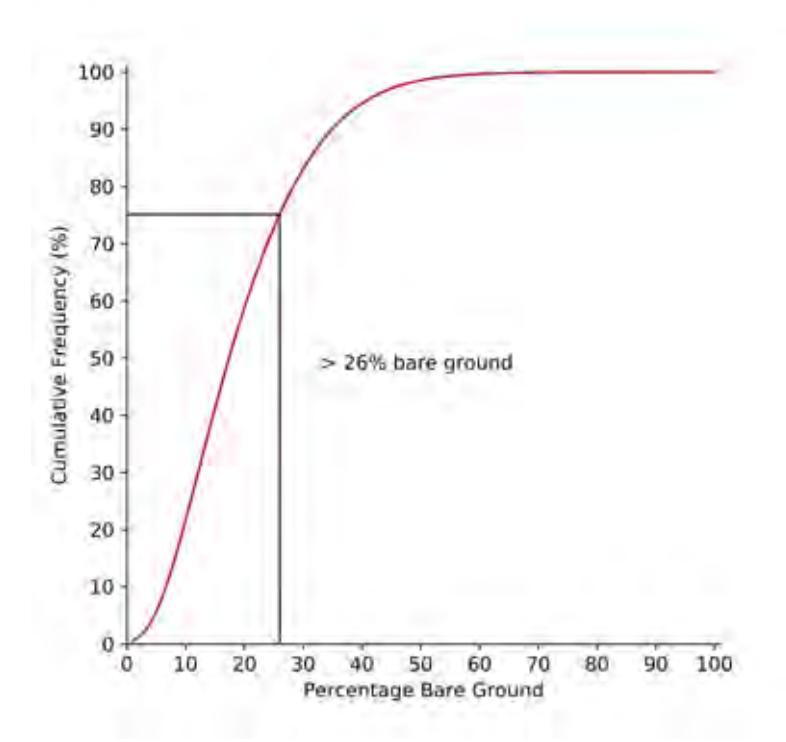
Figure 34: Percentage cumulative frequency of varying levels of bare ground in 30-m square Landsat pixels in the Roper Pastoral District between September and November 2020 (spring composite). Areas with > 36% bare ground (threshold) are mapped in Figure 35.
