NORTHERN TERRITORY

ANNUAL REPORT 2019-20

In accordance with section 29(a) of the *Pastoral Land Act 1992*, I hereby submit for your information and presentation to Parliament, the Pastoral Land Board Annual Report into the land condition of the NT Pastoral Estate for the reporting period 1 October 2019 to 31 December 2020.

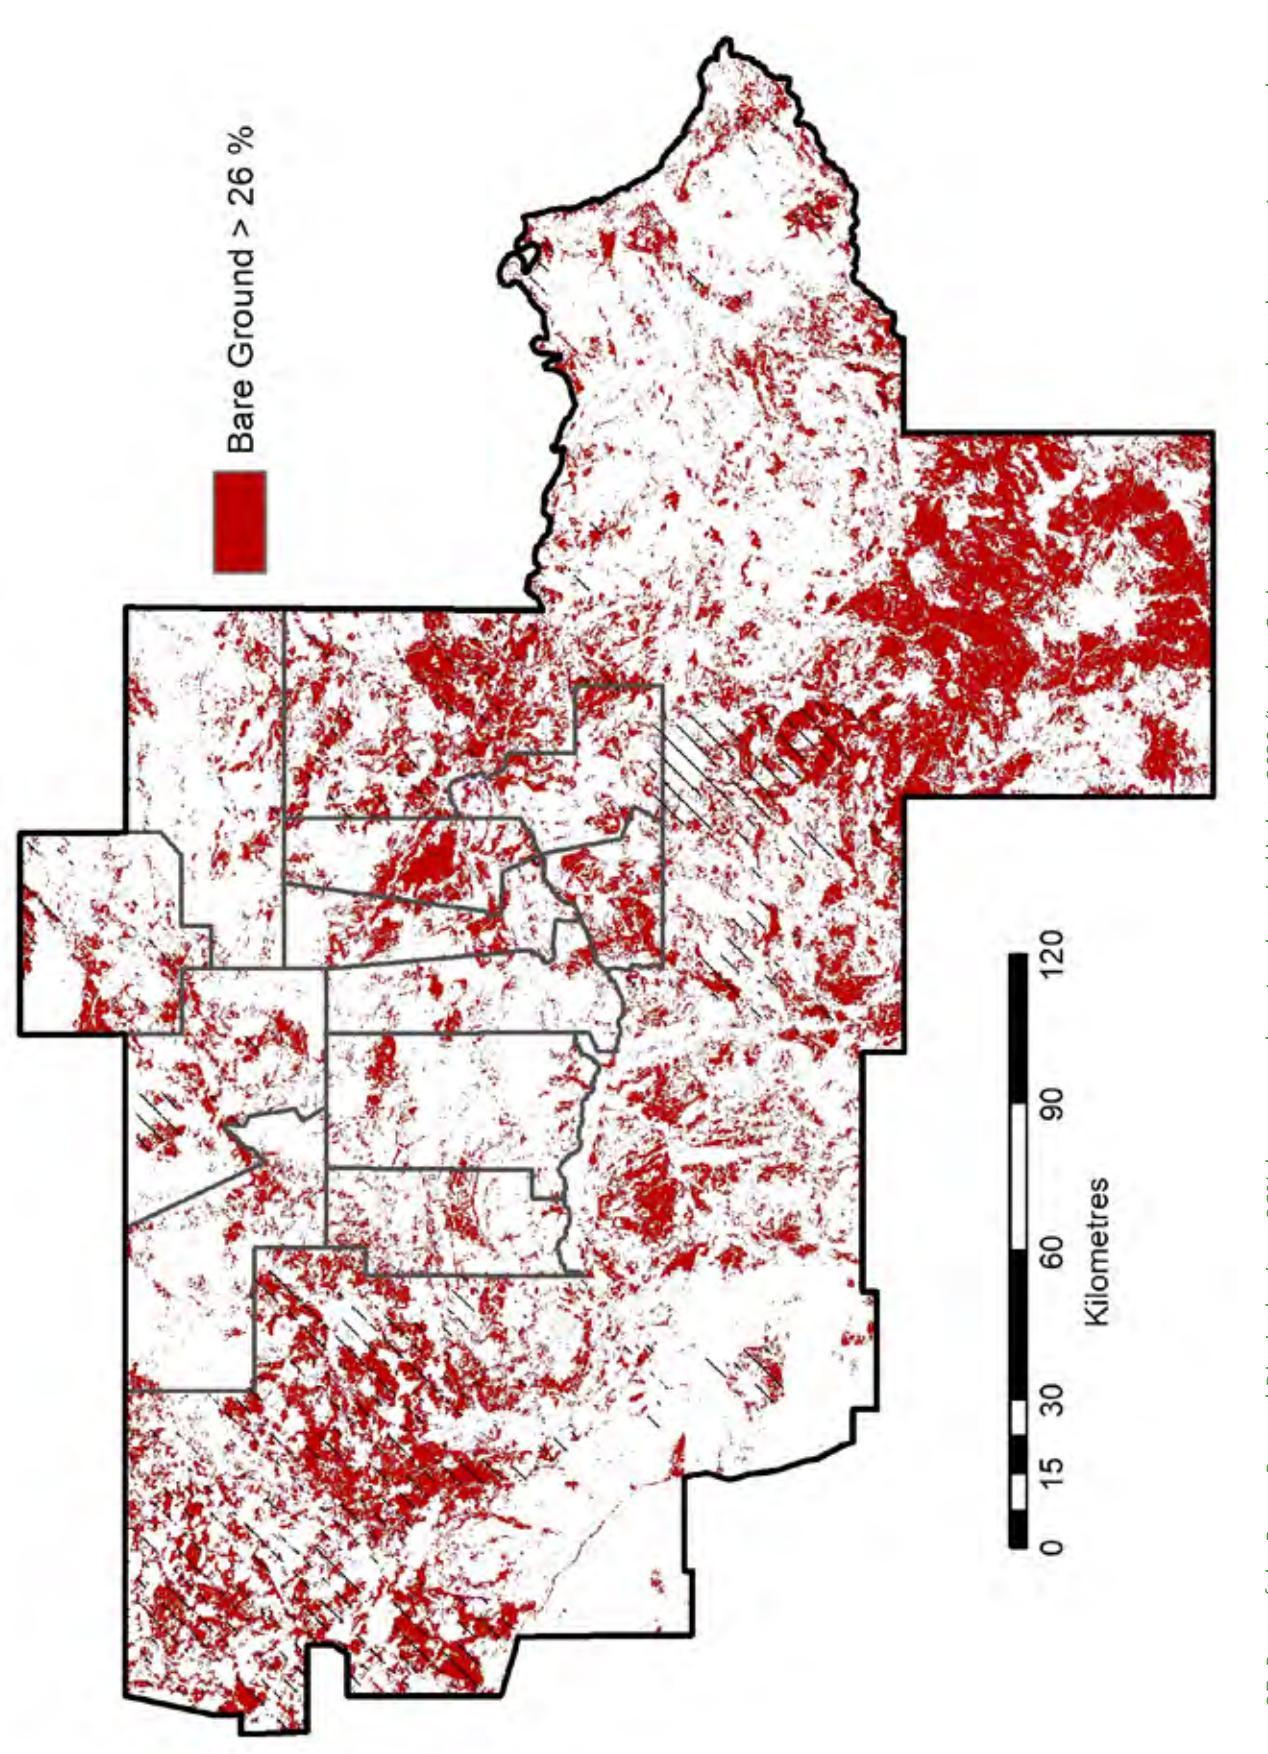
November 2020 shown with diagonal lines. Note that the threshold level of bare ground used for mapping purposes varies between pastoral districts. It is selected to show at what level approximately 25% of the district is affected. Figure 35: Parts of the Roper Pastoral District having >26% bare ground per Landsat pixel in late 2020 (Landsat Spring composite). Areas burnt between January and

Bare ground threshold across the District is presented in Figure 35 and includes areas burnt earlier in 2020; areas with bare ground >26% were distributed across the District.

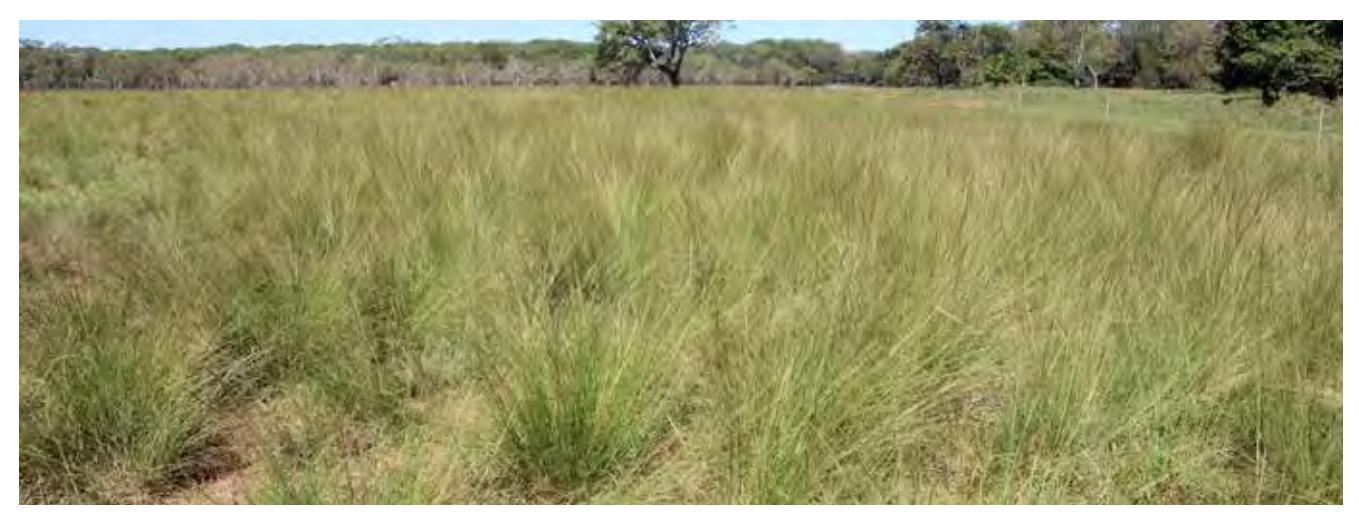
Photo 3: Rat's tail grass infested paddock

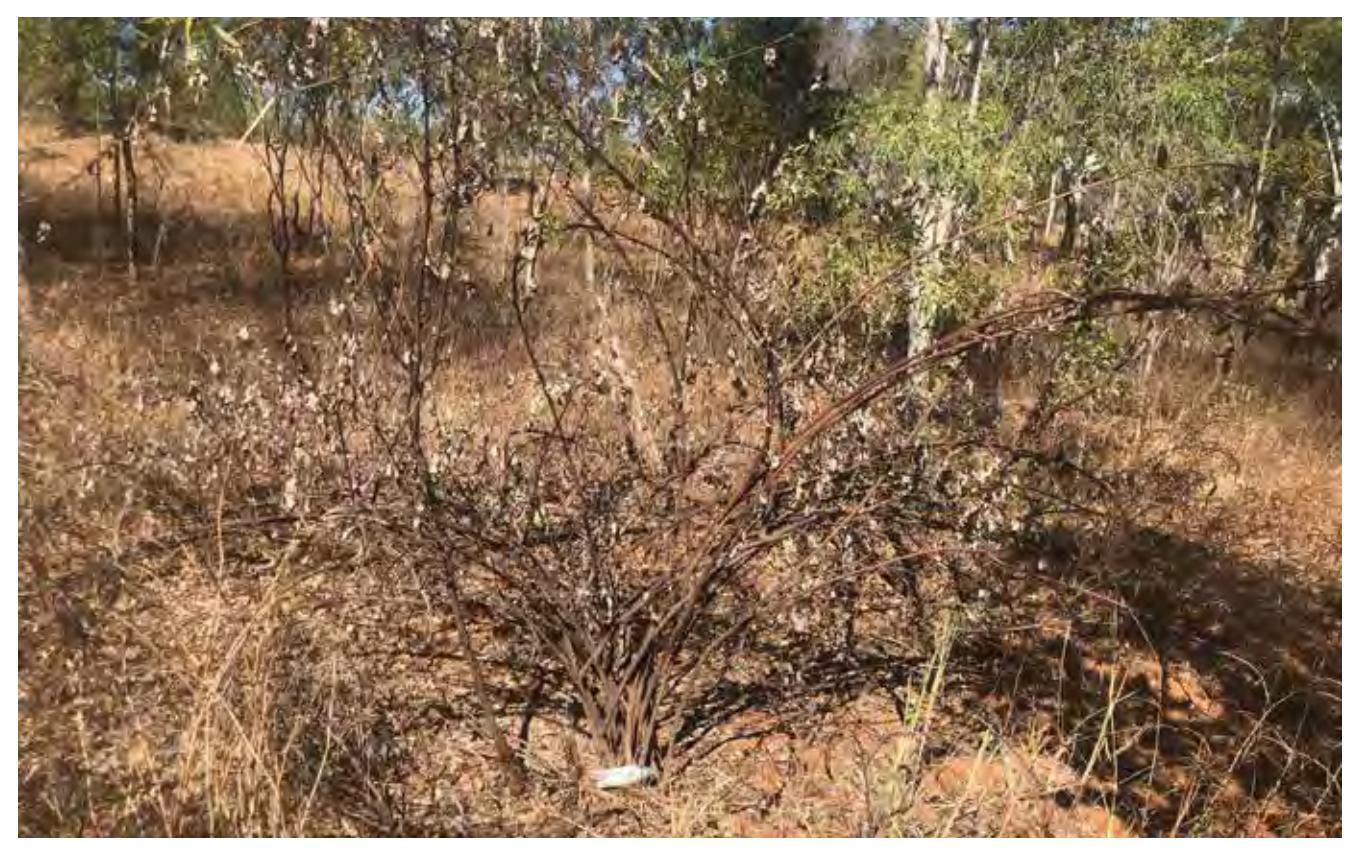
Photo 6: Treated rubber vine plant
